**AIRPROX REPORT No 2018080**

Date: 11 May 2018 Time: 0825Z Position: 5243N 00038W Location: 8nm NW Wittering

**PART A: SUMMARY OF INFORMATION REPORTED TO UKAB**

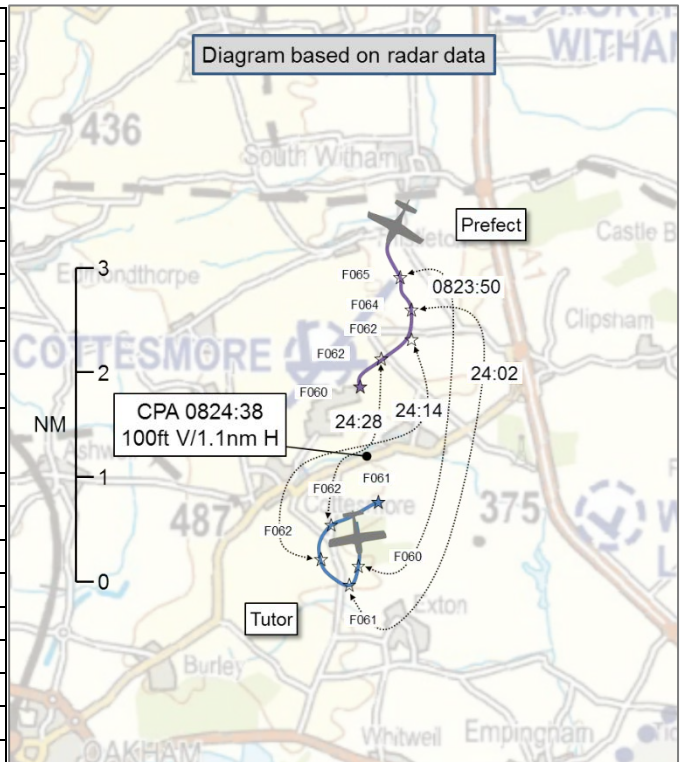
Recorded	Aircraft 1	Aircraft 2
Aircraft	Tutor	Prefect
Operator	HQ Air (Trg)	HQ Air (Trg)
Airspace	London FIR	London FIR
Class	G	G
Rules	VFR	VFR
Service	Traffic	Traffic
Provider	Wittering	Cranwell
Altitude/FL	FL056	FL059
Transponder	A, C, S	A, C, S
Reported		
Colours	White	White, blue
Lighting	HISL, landing nav	NK
Conditions	VMC	VMC
Visibility	30km	>10km
Altitude/FL	6000ft	5500ft
Altimeter	RPS (1006hPa)	NK
Heading	090°	NK
Speed	100kt	NK
ACAS/TAS	TAS and FLARM	TAS
Alert	Alert	Alert
Separation		
Reported	<500m'	NK
Recorded	300ft V/1.1nm H

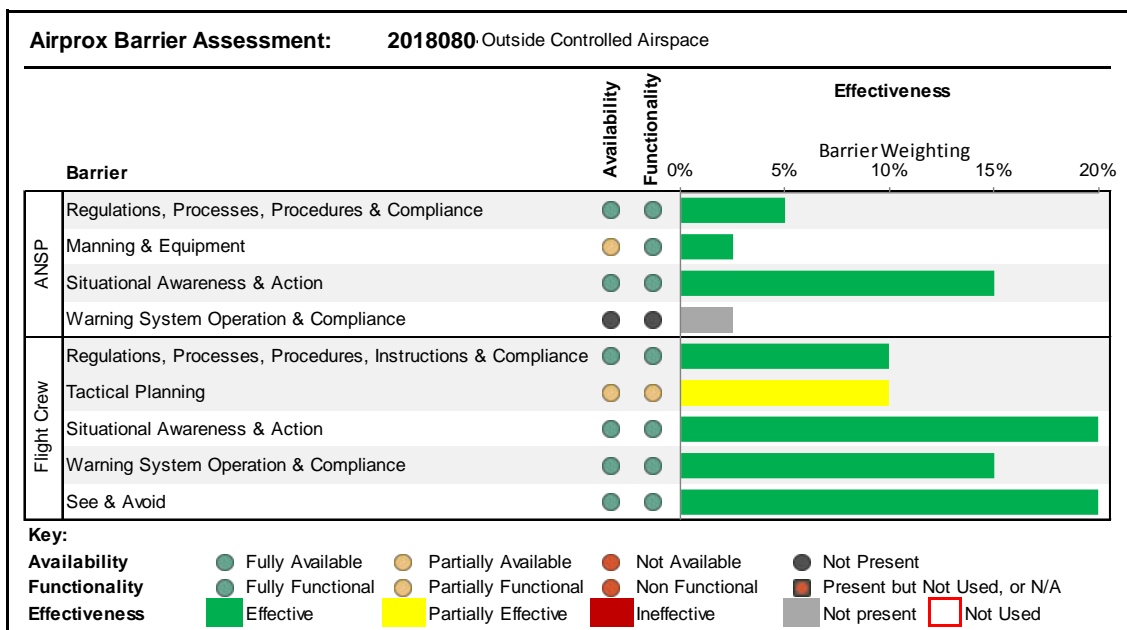
**Manning and Equipment** were assessed as **fully effective** but **partially available** due to manning and infrastructure limitations at Wittering which had caused bandboxing of positions.

**Tactical Planning** was assessed as **partially effective** because neither crew had information on the sector booking of the other.
