AIRPROX REPORT No 2018111

Date: 23 May 2018 Time: 1045Z Position: 5116N 00015W Location: 1.5nm NW Reigate

PART A: SUMMARY OF INFORMATION REPORTED TO UKAB

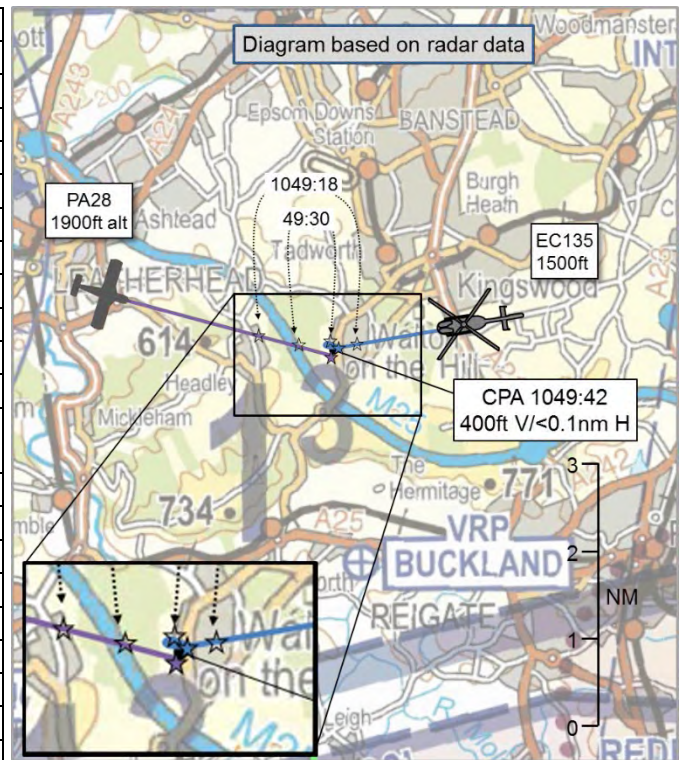
Recorded	Aircraft 1	Aircraft 2
Aircraft	EC135	PA28
Operator	NPAS	Civ FW
Airspace	London FIR	London FIR
Class	G	G
Rules	VFR	IFR
Service	Basic	Basic
Provider	Redhill	Farnborough
Altitude/FL	1500ft	1900ft
Transponder	A, C, S	A, C
Reported		
Colours	Blue, Yellow	Blue, White
Lighting	Strobes, Nav, HISLs	Strobes
Conditions	VMC	IMC
Visibility	15km	1km
Altitude/FL	1200ft	1900ft
Altimeter	QNH	NK
Heading	090°	090°
Speed	40kt	120kt
ACAS/TAS	TCAS I (U/S)	Not fitted
Alert	None	N/A
Separation		
Reported	100ft V/0m H	600ft V
Recorded	400ft V/0.1nm H

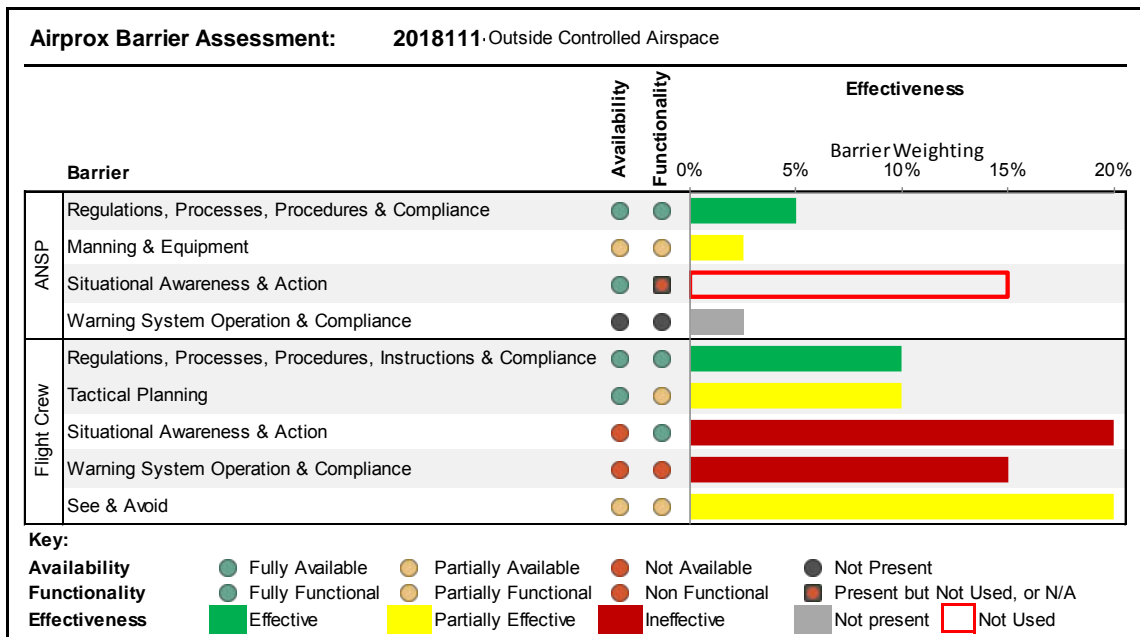
Warning System Operation and Compliance were assessed as **ineffective** because the TCAS on the EC135 did not alert.

See and Avoid were assessed as **partially effective** because the PA28 pilot was IMC and only able to achieve a late sighting in a gap in the clouds.
