**AIRPROX REPORT No 2018187**

Date: 18 Jul 2018 Time: 1831Z Position: 5150N 00040E Location: ivo Rivenhall

**PART A: SUMMARY OF INFORMATION REPORTED TO UKAB**

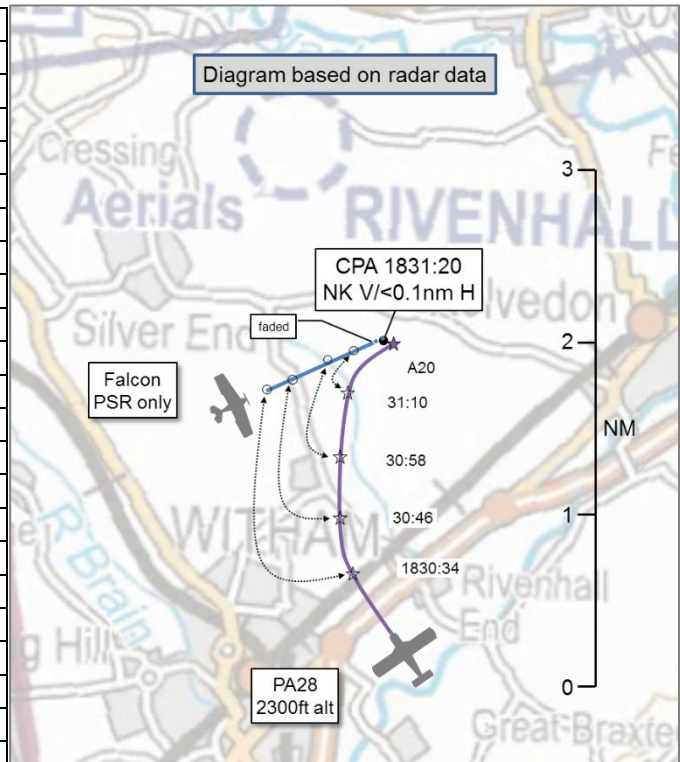
Recorded	Aircraft 1	Aircraft 2
Aircraft	X-Air Falcon	PA28
Operator	Civ FW	Civ FW
Airspace	London FIR	London FIR
Class	G	G
Rules	VFR	VFR
Service	None	Basic
Provider	N/A	Southend
Altitude/FL	NK	2000ft
Transponder	Not fitted	A, C ,S
Reported		
Colours	Dark blue	Blue
Lighting	Not fitted	NK
Conditions	VMC	VMC
Visibility	>10km	'Unlimited'
Altitude/FL	2100ft	2400ft to 1800ft
Altimeter	QNH (1016hPa)	NK
Heading	025°	NK
Speed	55kt	NK
ACAS/TAS	Not fitted	Not fitted
Separation		
Reported	20ft V/20m H	Not seen
Recorded	NK V/<0.1nm H

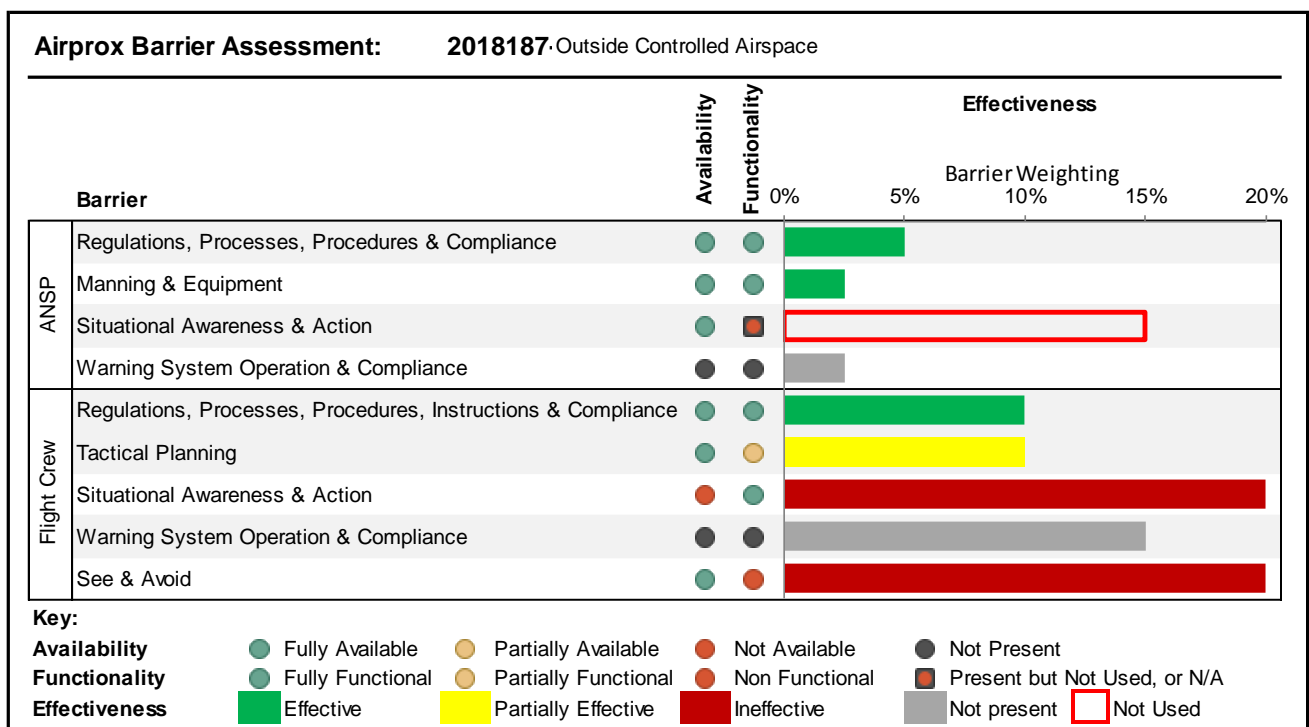
**Situational Awareness and Action** were assessed as **ineffective** because neither pilot was aware of the proximity of the other aircraft until after CPA.

**See and Avoid** were assessed as **ineffective** because the PA28 crew did not see the Falcon and the Falcon pilot did not see the PA28 until after CPA.
