AIRPROX REPORT No 2018211

Date: 09 Aug 2018 Time: 0927Z Position: 5817N 00260W Location: 10nm SE Wick

PART A: SUMMARY OF INFORMATION REPORTED TO UKAB

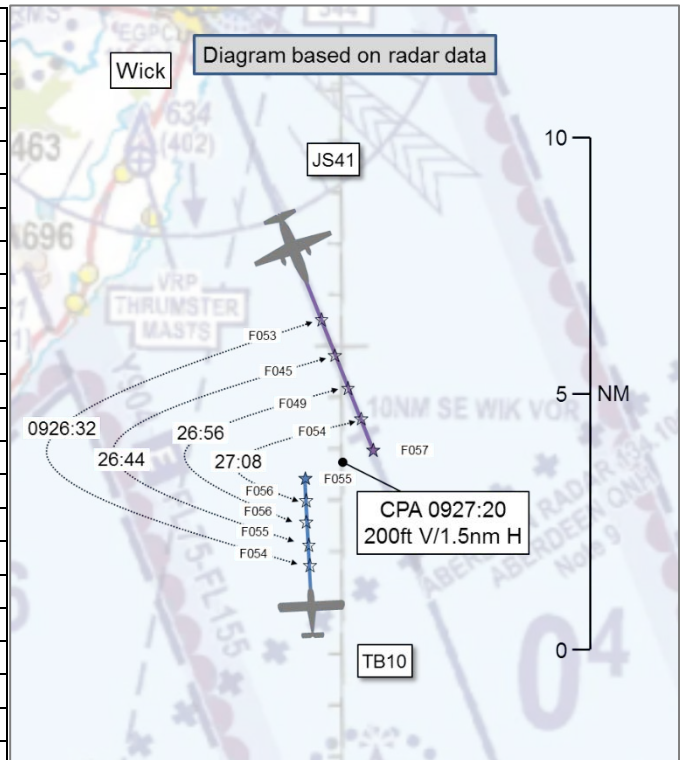
Recorded	Aircraft 1	Aircraft 2
Aircraft	TB10	JS41
Operator	Civ FW	CAT
Airspace	Scottish FIR	Scottish FIR
Class	G	G
Rules	VFR	IFR
Service	Basic	None ¹
Provider	Wick	Scottish Centre
Altitude/FL	FL56	FL56
Transponder	A,C,S	A,C,S
Reported		
Colours	NK	Company
Lighting	NK	NK
Conditions	VMC	VMC
Visibility	NK	10nm
Altitude/FL	5500ft	FL50
Altimeter	QNH	1013hPa
Heading	NK	160°
Speed	NK	220kt
ACAS/TAS	Not fitted	TCAS II
Alert	N/A	TA
Separation		
Reported	Not reported	Not seen
Recorded	200ft V/1.5nm H

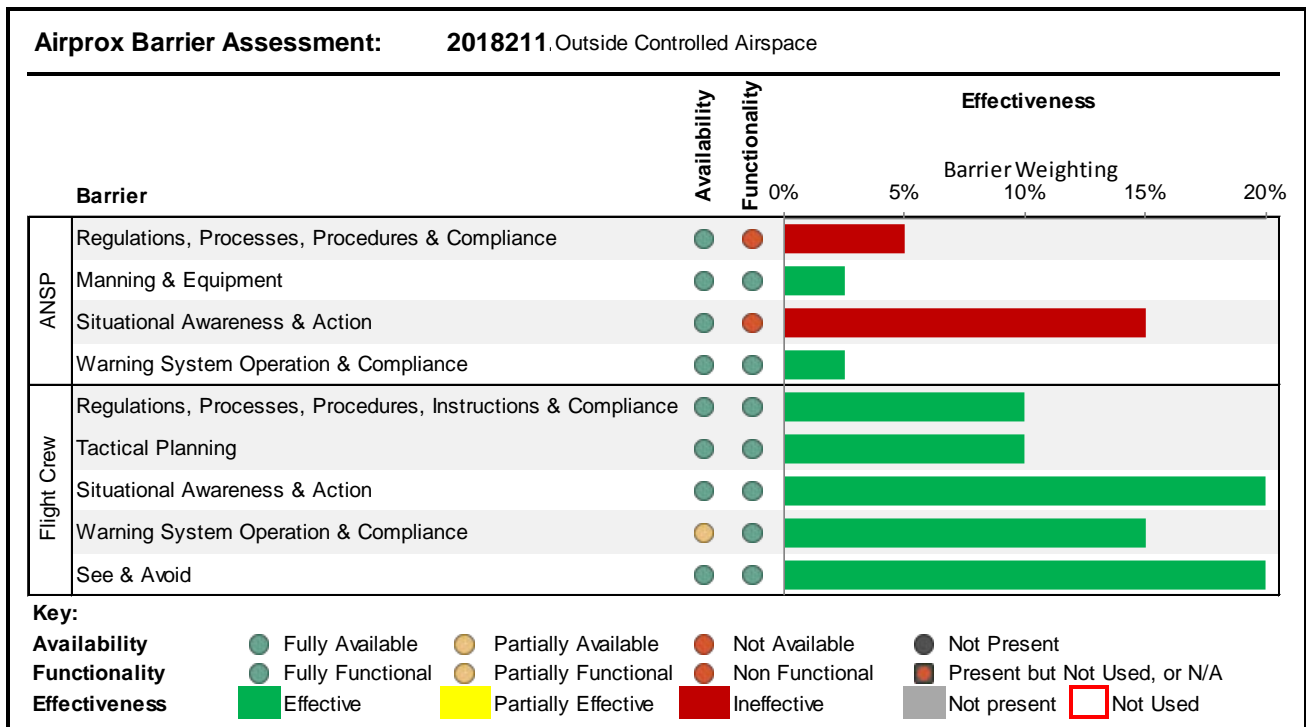
Warning System Operation and Compliance were assessed as **fully effective** but only partially available because only the JS41 was equipped with an electronic warning system.
