**AIRPROX REPORT No 2018310**

Date: 30 Nov 2018 Time: 1138Z Position: 5136N 00046E Location: Southend CTR

**PART A: SUMMARY OF INFORMATION REPORTED TO UKAB**

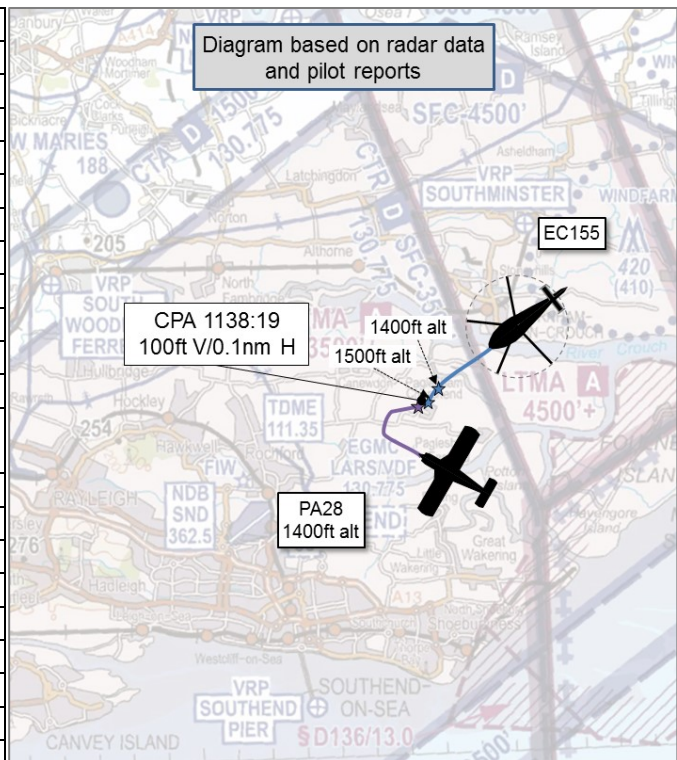
Recorded	Aircraft 1	Aircraft 2
Aircraft	EC155	PA28
Operator	Civ Helo	Civ FW
Airspace	Southend CTR	Southend CTR
Class	D	D
Rules	IFR	VFR
Service	Radar Control	Radar Control
Provider	Southend	Southend
Altitude/FL	1500ft	1400ft
Transponder	A, C, S	A, C, S
<b>Reported</b>		
Colours	White	Blue, White
Lighting	Landing, Strobe, Nav	Not reported
Conditions	VMC	VMC
Visibility	>10km	10km
Altitude/FL	1300ft	1000ft
Altimeter	QNH (1006hPa)	NK (1008hPa)
Heading	234°	Orbiting
Speed	120kt	80kt
ACAS/TAS	TCAS I	Unknown
Alert	None	Unknown
<b>Separation</b>		
Reported	300ft V/300m H	Not reported
Recorded	100ft V/0.1nm H

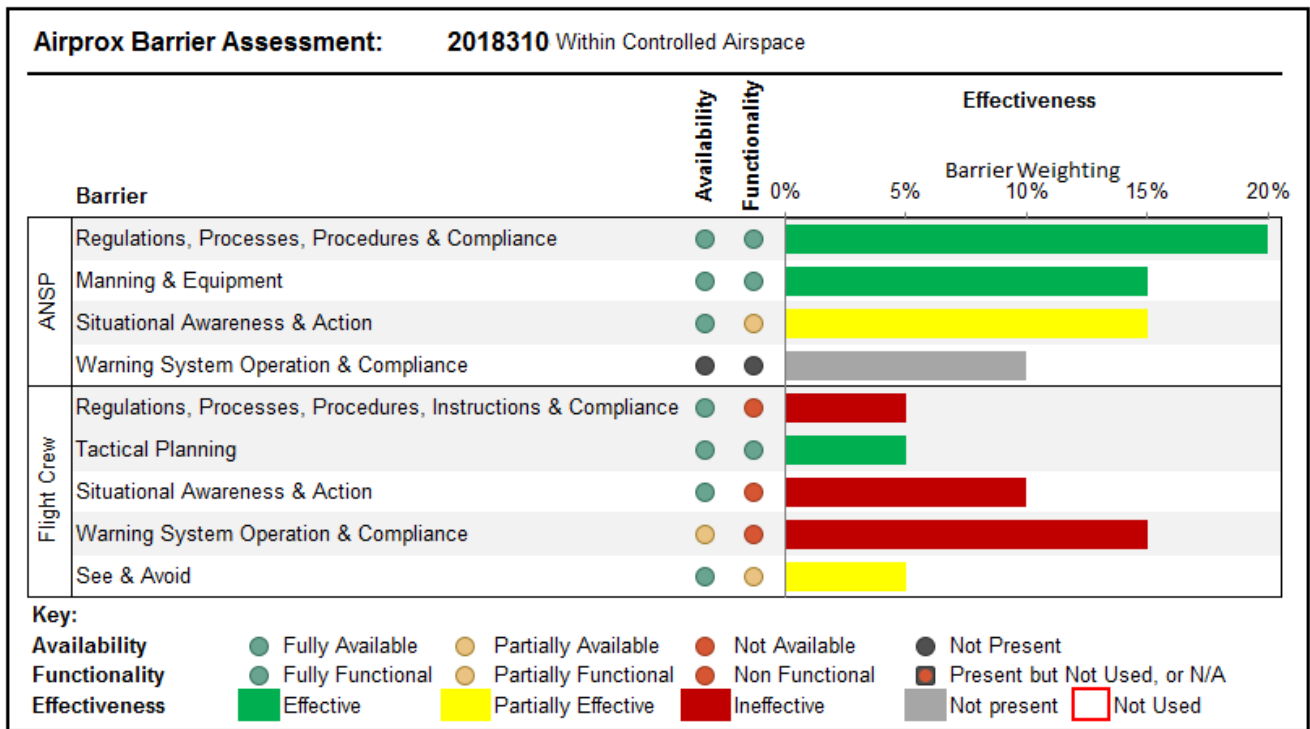
**Regulations, Processes, Procedures, Instructions and Compliance** were assessed as **ineffective** because the PA28 pilot did not follow the correct procedure for a radio failure at Southend.
