## AIRPROX REPORT No 2017045

Date: 25 Mar 2017 Time: 1028Z Position: 5217N 00136W Location: 6.5nm SW Coventry

### PART A: SUMMARY OF INFORMATION REPORTED TO UKAB

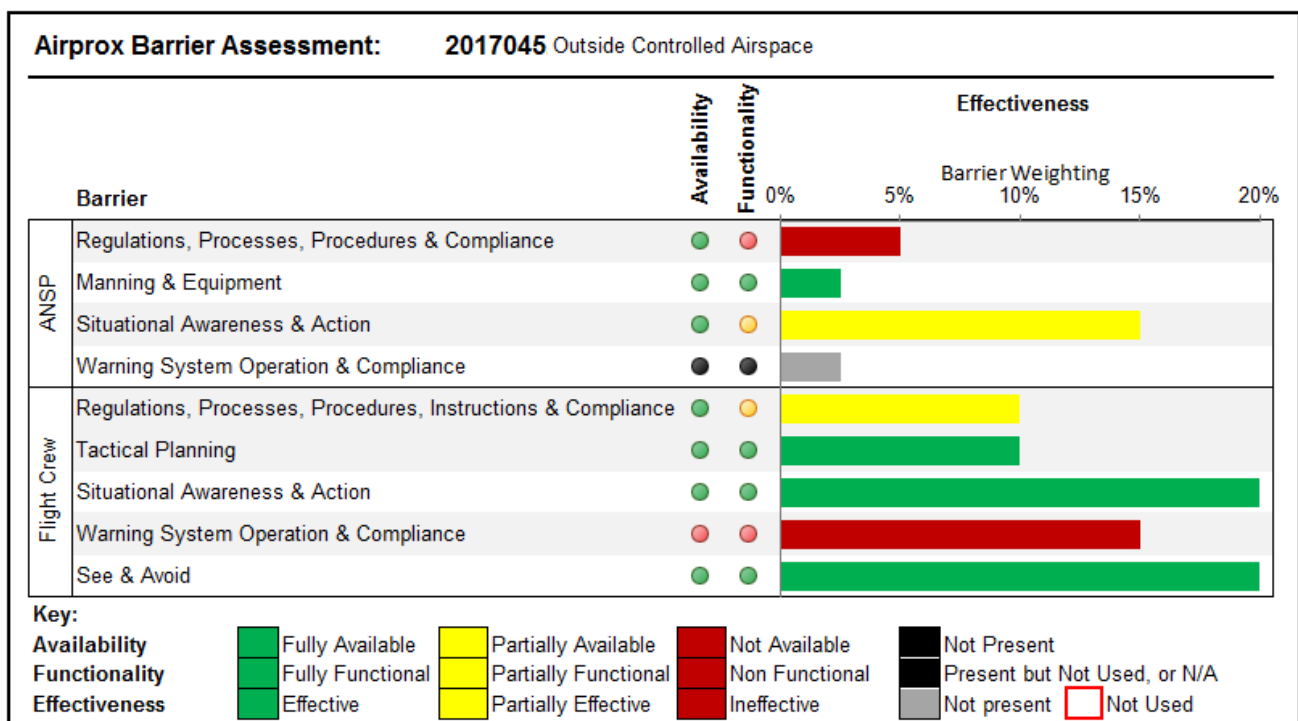
**Regulations, Processes, Procedures, Instructions & Compliance** were assessed as **partially effective** because although the B737 pilot was effectively receiving radar vectors and a TS, he had only asked for what was considered an inappropriate Basic Service in that airspace.

**Warning System Operation and Compliance** was assessed as **ineffective** because although the B737 was fitted with TCAS II it could not alert due to the unknown aircraft not transponding.
