**AIRPROX REPORT No 2017130**

Date: 21 Jun 2017 Time: 1721Z Position: 5040N 00133W Location: Freshwater Bay, IoW

**PART A: SUMMARY OF INFORMATION REPORTED TO UKAB**

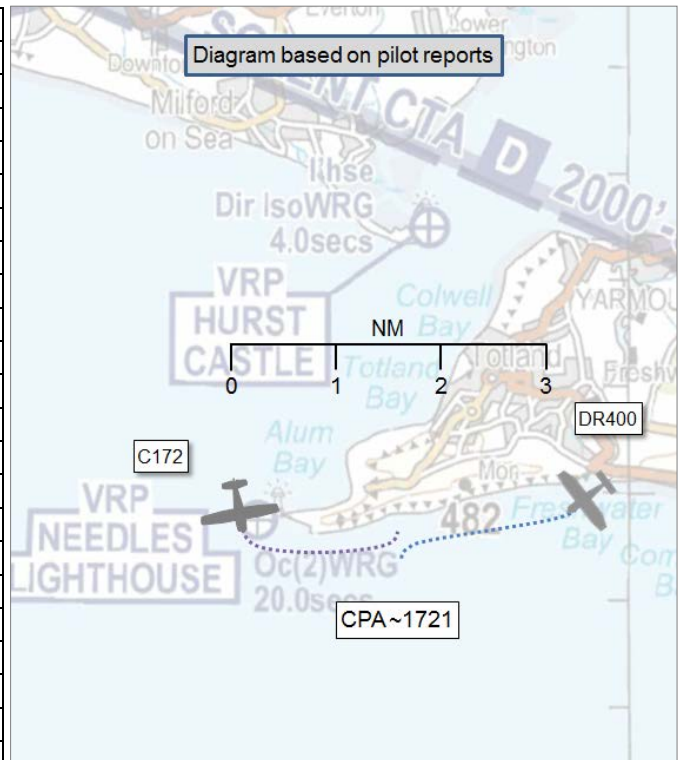
**THE DR400 PILOT** reports that he had descended to 500ft overhead Freshwater Bay after notifying Solent Approach of his intentions. He turned west, following the coastline approximately 200m offshore. He wasn't advised by ATC of any aircraft in the area (Basic Service only), nor did he request that information. He had been advised of traffic by the controller prior to the event and later by subsequent controllers despite being on a Basic Service. Approaching the Needles, he saw a white-and-blue Cessna 152 or 172 type aircraft at ½nm in the 12 o'clock position on a reciprocal heading on a collision course. He verbally notified the passenger and initiated a 30° AOB left-hand turn without losing sight of the other aircraft. The Cessna simultaneously conducted a left-hand turn towards the coastline at the same time. About 5secs later, the aircraft passed approximately 50m from each other with the Cessna very slightly higher and off the right wing. The DR400 pilot decided not to report an Airprox on the radio as the controllers were busy and he wanted to focus on flying in the area on a hazy day. The pilot was also new to UK airspace. He did not hear R/T from the Cessna pilot or ATC with respect to the Airprox.

**THE C172 PILOT** reports having rounded the needles heading eastbound when his passengers pointed out that there was an opposing aircraft slightly below and about 10° to the starboard side. He saw a white Robin-type aircraft at a range of ¾nm and turned to port to increase the distance between them. Once the aircraft had cleared each other he turned back on course. The C172 pilot did not report an Airprox.
