**AIRPROX REPORT No 2017131**

Date: 26 Jun 2017 Time: 1316Z Position: 5204N 00044W Location: W Cranfield

**PART A: SUMMARY OF INFORMATION REPORTED TO UKAB**

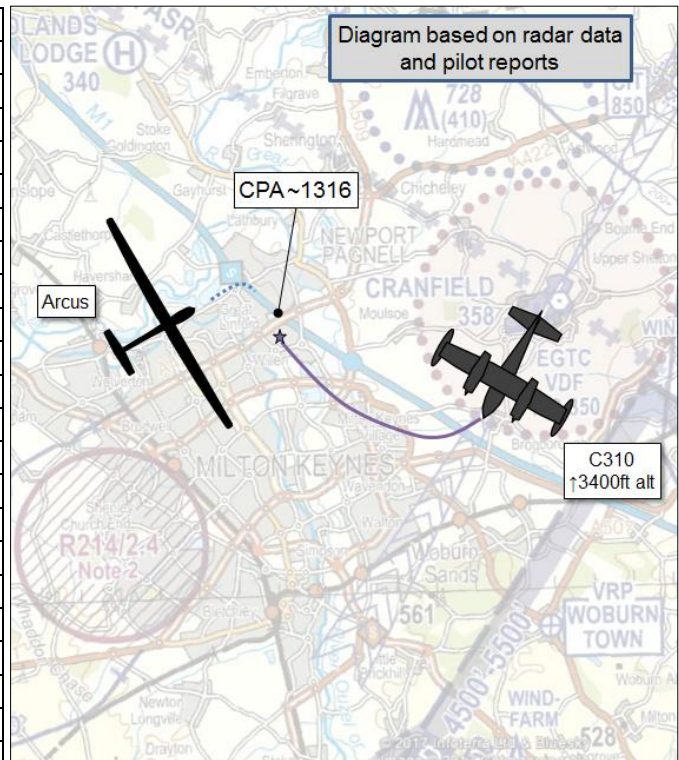
Recorded	Aircraft 1	Aircraft 2
Aircraft	Arcus	Cessna 310
Operator	Civ Pte	Civ Trg
Airspace	London FIR	London FIR
Class	G	G
Rules	VFR	VFR
Service	None	Basic
Provider		Cranfield
Altitude/FL	NK	3400ft
Transponder	Off	A, C, S
<b>Reported</b>		
Colours	White	White
Lighting	Nil	Anti-Cols
Conditions	VMC	VMC
Visibility	25nm	>10km
Altitude/FL	3500ft	3000ft
Altimeter	QNH	QNH
Heading	Turning	300°
Speed	50kt	160kt
ACAS/TAS	PowerFLARM	Not fitted
Alert	Unknown	N/A
<b>Separation</b>		
Reported	0ft V/25-35m H	100ft V/100m H
Recorded	NK

**THE ARCUS PILOT** reports that he was turning right in a thermal when a twin-engine aircraft flew straight past the cockpit at the same level, 25-35m away, heading north-west; it appeared to maintain a straight line, with no avoidance action.

Subsequent to the UKAB meeting the Arcus pilot confirmed that he had tightened his right turn to avoid the C310.

He assessed the risk of collision as ‘High’.

**THE CESSNA 310 PILOT** reports that he was on a type-conversion training flight for commercial operations; the PF was a student, with an instructor in the right-hand seat and another student as an observer in row 2. They had just flown an IFR sector to go VFR after a missed approach at Cranfield. They had commenced a climbing right turn to head 300° and, at the initial level off, spotted a glider in the 1 to 2 o'clock. The instructor commanded a right turn to increase separation, but the student was slow to respond, so the instructor took over to increase bank and started a descent. He did not file an Airprox at the time because he did not consider it to be one; however, he wished to apologise to the glider pilot if he thought separation was compromised. He noted that contributory factors were that there was a very high cockpit workload as they changed from IFR to VFR, and changed course and transponder codes at the same time, but that the second student was there in mitigation as an extra look-out. The aircraft was not fitted with TCAS at the time, although it has been since.

He assessed the risk of collision as ‘None’.
