AIRPROX REPORT No 2017190

Date: 10 Aug 2017 Time: 1046Z Position: 5213N 00251W Location: Shobdon (elev: 317ft)

PART A: SUMMARY OF INFORMATION REPORTED TO UKAB

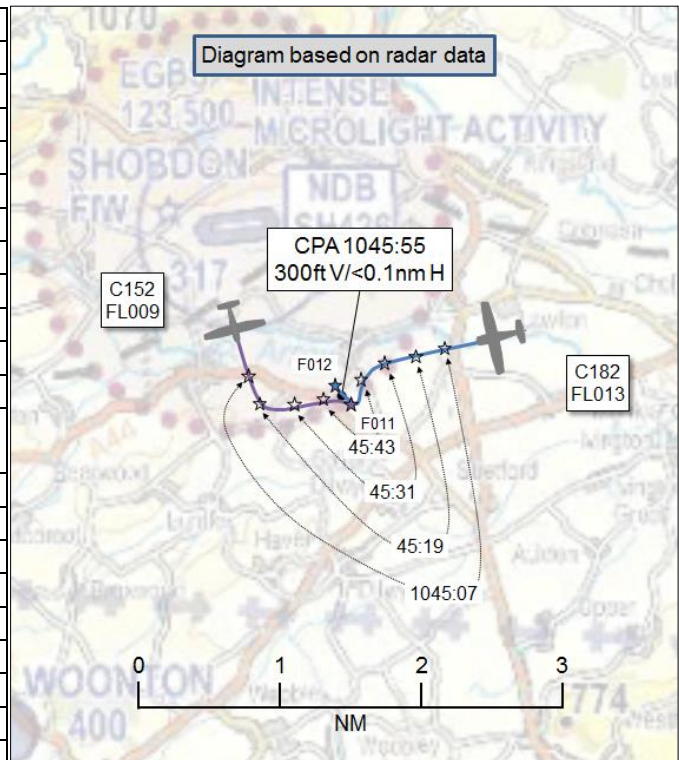
Recorded	Aircraft 1	Aircraft 2
Aircraft	C182	C152
Operator	Civ Club	Civ Trg
Airspace	Shobdon ATZ	ATZ
Class	G	G
Rules	VFR	VFR
Service	Information	Information
Provider	Shobdon	Shobdon
Altitude/FL	FL011	FL009
Transponder	A, C, S	A, C, S
Reported		
Colours	White/blue/red	White/blue/brown
Lighting	Strobe, beacon, landing	Nav, landing
Conditions	VMC	VMC
Visibility	>10km	>10km
Altitude/FL	1100ft	1000ft
Altimeter	QFE (NK hPa)	QFE (NK hPa)
Heading	260°	090°
Speed	90kt	90kt
ACAS/TAS	Not fitted	Not fitted
Separation		
Reported	100ft V/200m H	200ft V/400m H
Recorded	300ft V/<0.1nm H ¹
