AIRPROX REPORT No 2017210

Date: 25 Aug 2017 Time: 1220Z Position: 5729N 00333W Location: 15nm S Lossiemouth

PART A: SUMMARY OF INFORMATION REPORTED TO UKAB

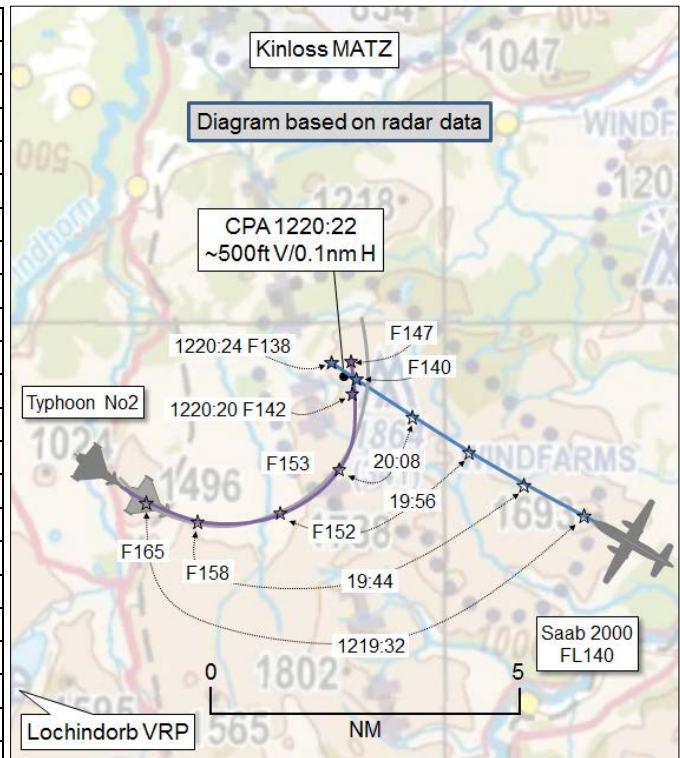
Recorded	Aircraft 1	Aircraft 2
Aircraft	Saab 2000	Typhoon No2
Operator	CAT	HQ Air (Ops)
Airspace	Scottish FIR	Scottish FIR
Class	G	G
Rules	IFR	IFR
Service	Deconfliction	Traffic
Provider	Prestwick	Lossiemouth
Altitude/FL	FL139	FL147
Transponder	A,C,S	A,C (S off)
Reported		
Colours	White	Grey
Lighting	NK	HISLs, nav
Conditions	VMC	VMC
Visibility	10km	NK
Altitude/FL	FL140	FL147
Heading	NK	NK
Speed	260kt	300kt
ACAS/TAS	TCAS II	Not fitted
Alert	RA	N/A
Separation		
Reported	NK	600ft V/NK H
Recorded	~500ft V/0.1nm H ¹

¹ Interpolated between the radar returns at 1220:20 and 1220:24.
