AIRPROX REPORT No 2016001

Date: 6 Jan 2016 Time: 1300Z Position: 5054N 00233W Location: South of Yeovil

PART A: SUMMARY OF INFORMATION REPORTED TO UKAB

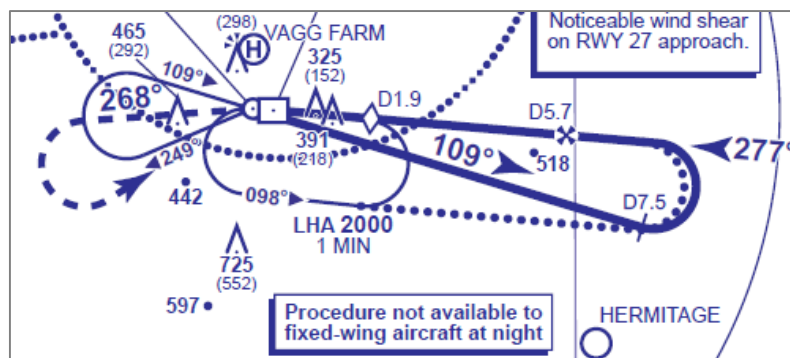
Figure 1: Yeovil/Westland NDB (L)/DME Approach RW27 (UK AIP AD 2-EGHG-8-6)

The A109 (SSR code 4355) was flying the NDB (L)/DME alternate (racetrack) approach procedure (Figure 1) for Runway 27 at Yeovil (Westland) Aerodrome. The A109 was in receipt of a Basic Service from Westland Approach. At the time of the Airprox the A109 was beacon outbound in the procedure.
