AIRPROX REPORT No 2016109

Date: 15 Jun 2016 Time: 1734Z Position: 4943N 00209W Location: ENE Alderney airport

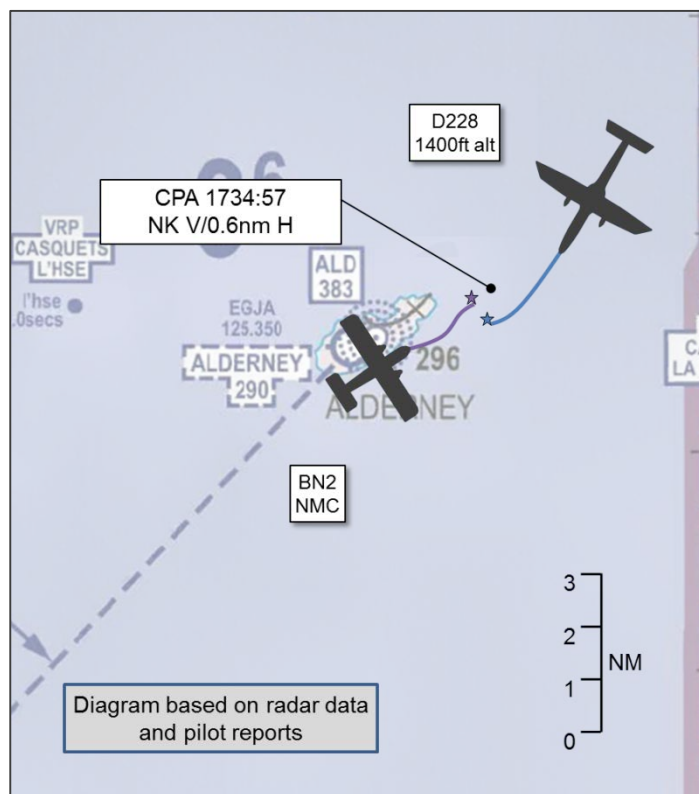
THE BN2 ISLANDER PILOT reports that he was conducting training to the west of Alderney and requested join for a west-east transit of Alderney simulating a cliff search followed by a join to long final for a touch-and-go on RW26. The initial clearance was to search the north of the island, but R/T made it apparent that a D228 was joining from the north; therefore, he requested and was approved a south cliff search as they flew towards Alderney. He heard the D228 pilot transferring from right base to final approach as they were south abeam the airport. He did not sight the traffic. He requested more traffic information and the D228 was reported 'on final'. The airport was 1.5nm behind his aircraft with the coastline now turning north into a bay. Whilst he was certainly concerned that he was not visual with the traffic, he was unconcerned about the risk of a collision because he knew that there was vertical separation throughout. However, in [turning left] following the coastline he looked back over his shoulder towards Alderney for the traffic and saw that he was going to cross the runway centreline. He could not see the traffic there, so he looked back away from the airport and saw the traffic to the east of him. He was approaching the D228's trajectory and, rather than reverse direction and cross once again through his trajectory but at a closer range, he elected to fly further left and to the north. In so doing he knew that he would infringe the clearance to remain south of Alderney but he could not make a radio call to this effect because the frequency was busy. Once clear to the north, the radio calls ceased and the Aerodrome controller queried his flight path. Quite rightly he observed that he had not complied with his clearance to remain south. As he continued to the north he estimated that the lateral separation with the D228 was 2nm but that there was also vertical separation throughout.
