AIRPROX REPORT No 2016115

Date: 25 Jun 2016 Time: 1459Z Position: 5347N 00106W Location: Burn

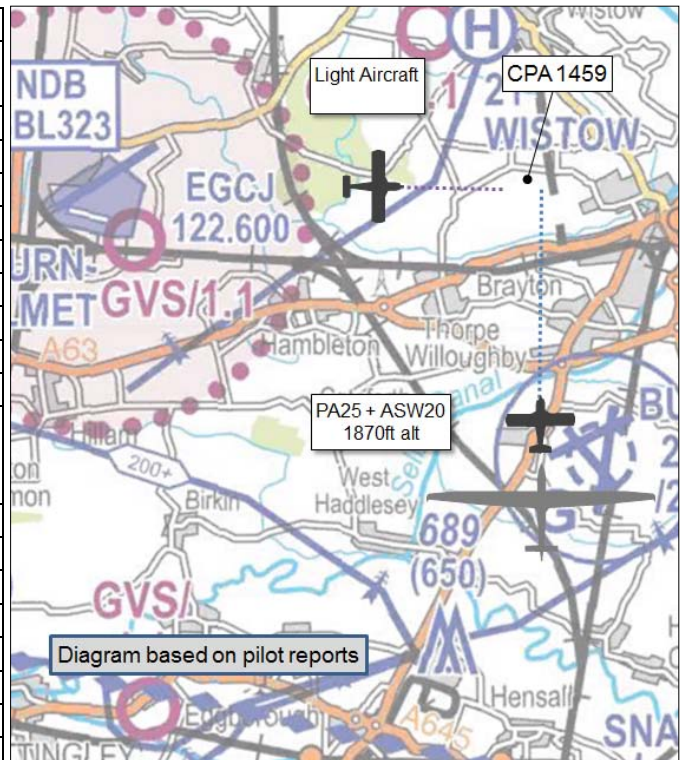
THE ASW20 PILOT reports taking off from Burn using an aero-tow heading north towards active cumulus clouds situated NE of Selby, whilst avoiding Selby town and Sherburn ATZ. There was a large number of slow-moving cumulo nimbus clouds in the area at the time, cloud bases varied between 3000 and 4500ft. As the aero-tow progressed north towards the cumulus clouds, the glider pilot suddenly noticed a light-aircraft approaching rapidly from the left heading directly towards the tug. A split second from impact it pulled up and turned hard left (to the north) and then away to the west. As soon as he saw the aircraft he radioed the tug shouting 'light aircraft closing from left' but by the time the call had been made the aircraft had passed over the top of the tug in a climbing left turn. He believed that had the other aircraft not pulled up at the last minute, there would have been a mid-air collision right in front of him. The incident took place at 1559.04, he called Burn base and asked that the Airprox be reported immediately. The tug and glider continued for another minute, releasing at 2200ft agl in a left-hand turn. As the turn continued, he believed he saw the Airprox aircraft orbiting left before heading off to the east. He noted that there is currently a NOTAM in place highlighting a permanent change in winch launch ceiling at Burn from 2000 to 3000ft, effective from 1/04/16 until such time as the 1:500000 map is re-issued.

He assessed the risk of collision as 'High'.
