**AIRPROX REPORT No 2016193**

Date: 29 Aug 2016 Time: 1119Z Position: 5111N 00105W Location: 1.5nm NW Lasham

**PART A: SUMMARY OF INFORMATION REPORTED TO UKAB**

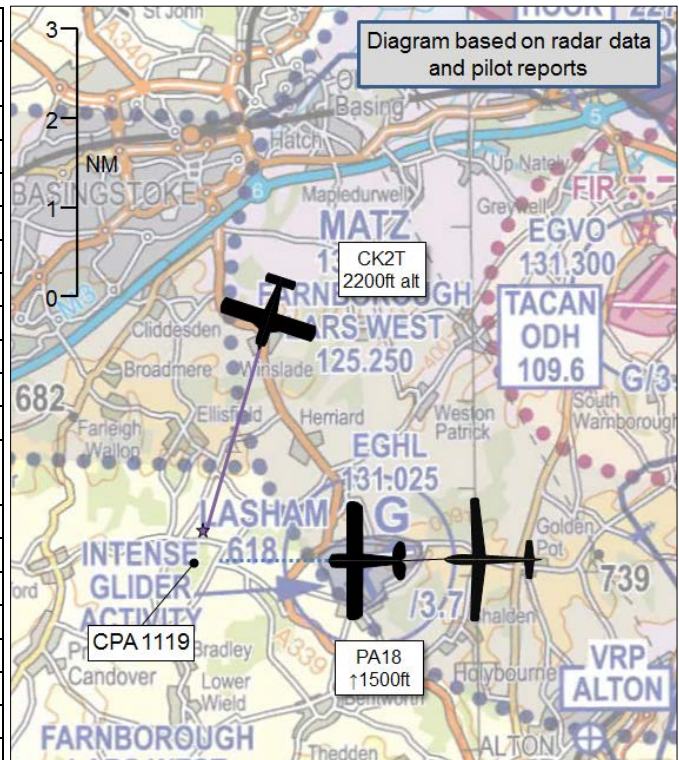
**THE PA18 PILOT** reports that he was towing a glider and first became aware of the traffic as it emerged from behind his left wing-tip [going away] some 200m laterally and slightly above, heading SW. He was concerned that the traffic might conflict with the glider winch launch activity, but watched the aircraft continue to the SW, its track taking it about ½ km to the west of the aerodrome. Upon landing, in discussions with other observers (the glider pilot on tow and the pilot of another aerotow combination following behind), it became apparent that there had been a real risk of collision prior to his visual contact.

**THE CT2K PILOT** reports that he was given approval by Farnborough LARS to route through the Odiham MATZ. He was given a squawk, and a Basic Service, and duly entered the MATZ. He was using his SkyDemon, which gives a 2nm alert around all glider sites and, because it looked like his track would take him directly over Lasham, he altered course to avoid it. Outside of the 2nm 'zone', NW of Lasham, he was cruising at 2000ft when he saw a tow-plane, with a glider, climbing towards him. He immediately started to climb to improve separation and the tow-plane passed below and behind, still appearing to climb. Seconds after it had passed, Farnborough called to alert him to 'multiple gliders in the area' and he replied that one had just passed very close; however, he did not think at the time that it was close enough to be considered an Airprox and so continued his routing to his destination.
