## AIRPROX REPORT No 2016219

Date: 10 Oct 2016 Time: 1220Z Position: 5046N 00008E Location: 3nm NE Seaford VOR

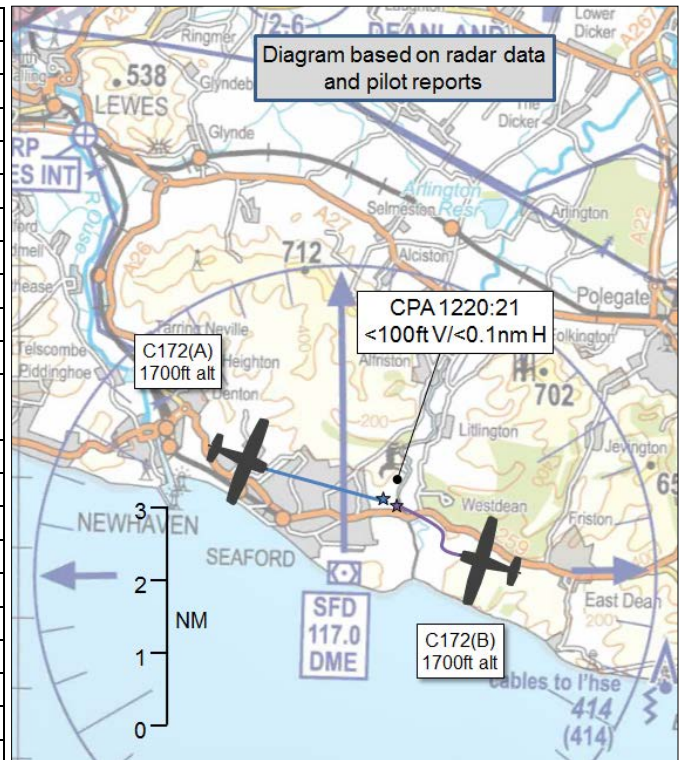
**THE C172(A) PILOT** reports that he was near the Seaford VOR, turning at 15° AOB to fly along the Cuckmere River, when a C172 came from behind to the starboard side. It flew over the top descending and turning left. He saw the underside of the aircraft appear very close as it went over the top and it appeared that the other aircraft almost flew into him. By the time he had seen it, it had already passed so there was no time to take any avoiding action.

**THE C172(B) PILOT** reports that he was on a training flight and sitting in the right-hand seat. Although not matching C172(A) pilot's report, he described a geometry that saw him flying west of Seaford towards Cuckmere when he saw another aircraft on his right, tracking in from the coast, 3 to 4nm away. He monitored its track, fully aware that he would be in the other pilot's blindspot due to its high wing, and that the other pilot probably hadn't seen him. The other aircraft was tracking a steady north-easterly heading; because the other aircraft was on the right he performed a precautionary 90° left turn away from his track, expecting to see it appear on his right if it had maintained course. However, it did not appear as expected, so he turned further left and saw it low, left abeam, and although he was now on the right, he turned right to increase separation. It was clear that the other pilot was not visual with his aircraft, otherwise it would not have turned left towards him, he thought that when he came into view the other pilot must have been startled as he turned right behind and below and continued on an easterly heading. He opined that he would have expected the other pilot to 'lift the wing' and complete a thorough look-out before making any changes in heading, especially when operating at low altitudes in a high-wing aircraft. The weather was fine with excellent visibility and he was fully aware of the other aircraft, with sufficient distance between them to perform normal and smooth flight. At no time did he consider the contact to be endangering his aircraft.

In determining the cause, the Board quickly agreed that this had effectively been a non-sighting by both pilots. Assessing the risk, the Board considered this to be a high-risk event, where providence had played a large part in the two aircraft avoiding a collision; radar replays indicated that the separation was at the bare minimum and so they therefore assessed the incident as Category A.

Cause: Effectively a non-sighting by both pilots.
