AIRPROX REPORT No 2016232

Date: 04 Nov 2016 Time: 1030Z Position: 5136N 00105W Location: Benson MATZ

PART A: SUMMARY OF INFORMATION REPORTED TO UKAB

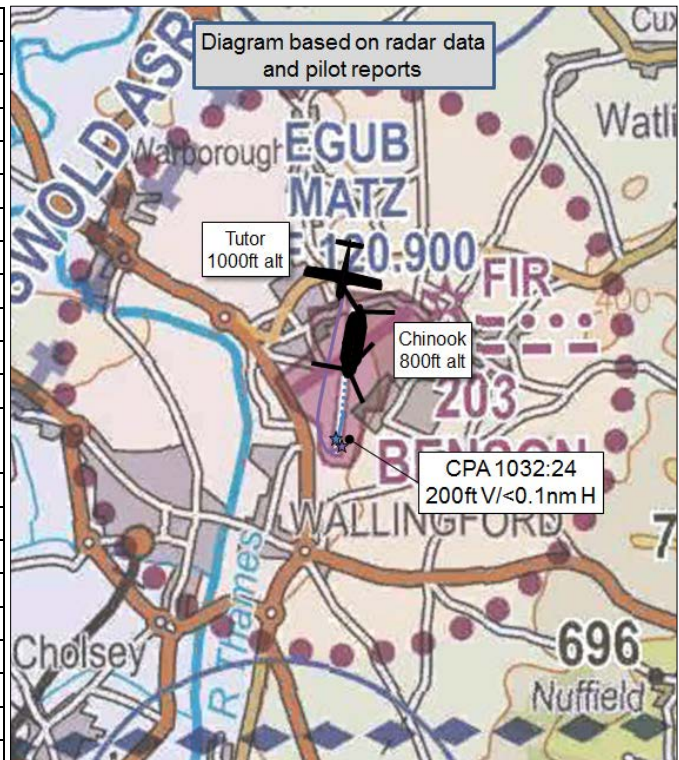
THE CHINOOK PILOT reports that he was flying an IF GH training sortie. A crew change was conducted on the Eastern grass before calling ready to copy departure details on the Tower frequency. Once details had been obtained, the NHP called ready for taxi RW 19, ATC held them in position to deconflict with Tutor traffic. Upon obtaining clearance to line up, the aircraft was manoeuvred to RW 19 and the NHP called ready for departure once they were on the RW heading. A departure clearance was given, and the RHS HP was given control for an IF TO. The No2 crewman called visual with a Tutor on the deadside and called his 'padlock' [UKAB Note: padlock is a military codeword for maintaining visual contact]. The crewman continued to monitor the Tutor which was approximately 200m to the right of the Chinook at around 500ft. The RHS HP conducted an IF TO and the NHP called Tower to advise a change to the Approach frequency. Shortly after that, the No2 crewman called that the Tutor was converging, followed by calling avoiding action to descend. The LHS NHP became visual with the Tutor, which had turned across the front of the Chinook as the converging call was made. As the avoiding action was called, the LHS simultaneously called to take control and descended the Chinook immediately with a slight right turn. Immediately on avoiding the Tutor, the Chinook continued descent to around 300ft, and Approach were advised of the Airprox, and that the IF departure was being terminated. The LHS maintained control of the Chinook and advised that a join for downwind RW 19 would be required. They were subsequently transferred to the Tower frequency and the Chinook was recovered to normal circuit height once all traffic had been identified. An approach was made to RW 19 and the aircraft was taxied clear of the active onto the Eastern Grass. Had avoiding action not been taken, the Chinook captain believes that the aircraft would have collided. The sortie was immediately terminated due to the severity of the incident.

THE TUTOR PILOT reports that he was flying solo in the circuit and was on his 5th circuit of the sortie. On this circuit he had requested a glide, and was aware of the Chinook on the eastern grass preparing for a SID. As he initiated his descent from 1500ft and called finals for RW 19 he was instructed to go around by ATC. Because he was at approximately 1300ft, he continued to descend to Tutor circuit height (800ft) and positioned to the deadside. As he did this he watched the Chinook hover taxi sideways onto the runway to line up for departure. On coming abeam with the threshold for RW 19 he called deadside. Shortly after this the Chinook pilot called airborne and to Approach, but at this point he had lost visual with the Chinook. He then focused his attention on regaining visual contact with the Chinook. Due to the Chinook being low and on his left-hand side (he was seated on the right-hand side), he had to dip his wing several times before regaining visual with it low in his 7 o'clock. At this point, he was comfortable to turn over the aircraft to rejoin the circuit. After establishing his level left hand turn, he watched the Chinook unexpectedly turn right towards him in his climb and go behind him. He assessed they passed within 150-200' of each other. He heard the subsequent radio call from the Chinook that he was unhappy with the position of the circuit traffic and the mention of an Airprox. After another 2 circuits he completed his sortie. On changing to ground frequency from the busy tower frequency, he passed his callsign and informed ATC of his intention to speak to the Chinook pilot to discuss the Airprox. His TAS was switched off during the sortie due to the busy circuit traffic, but he was comfortable with good SA on the other circuit traffic throughout.
