**AIRPROX REPORT No 2015021**

Date: 12 Mar 2015 Time: 1605 Z Position: 5306N 00009W Location: RAF Coningsby

**PART A: SUMMARY OF INFORMATION REPORTED TO UKAB**

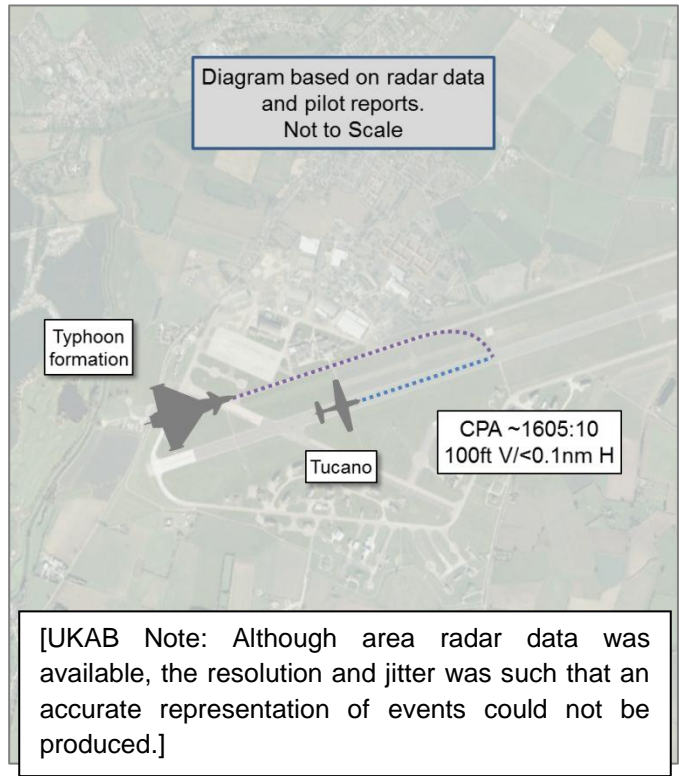
| Recorded | Aircraft 1 | Aircraft 2 |
|---|---|---|
| Reported | 50ft V/0m H | 100ft V/0m H |
| Recorded | 100ft V/<0.1nm H | |
