AIRPROX REPORT No 2015031

Date: 4 Apr 2015 Time: 1155Z Position: 5146N 00049W Location: 2km NW Henton NDB (Saturday)

PART A: SUMMARY OF INFORMATION REPORTED TO UKAB

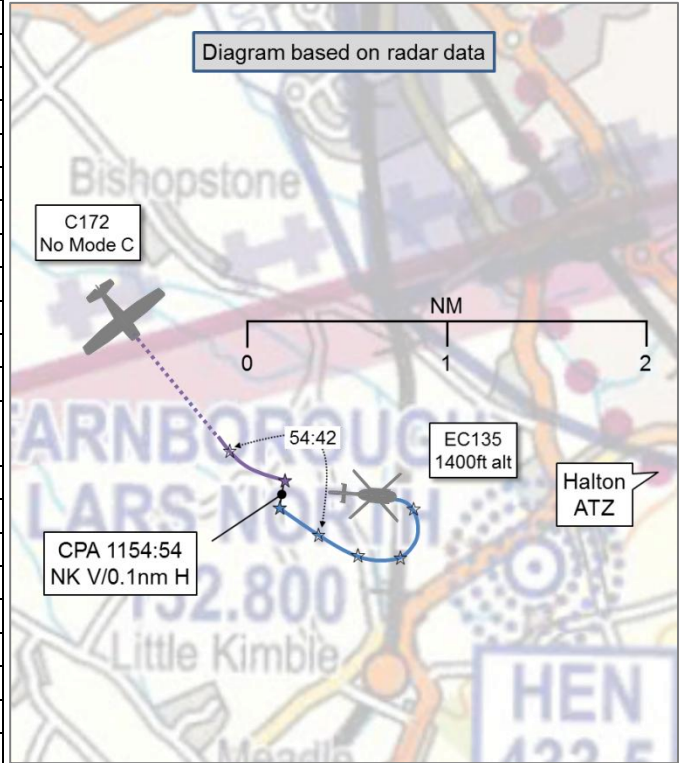
THE EUROCOPTER EC135 PILOT reports that whilst slowing the aircraft in readiness for a police task, prior to commencing a right-hand orbit, a clearance lookout was conducted and the other aircraft was seen. He reported sighting the other aircraft when it was 400ft on his right-hand side. An immediate left-hand level turn was initiated keeping the other aircraft in sight at all times with the assistance of police observers. He commented that there had been numerous other aircraft passing through or orbiting in the region at similar heights.

He assessed the risk of collision as 'High'.

The Board quickly decided that the cause of the Airprox was a sighting issue. The EC135 pilot had reported that he had only sighted the C172 at a range of 400ft, and the C172 pilot had not seen the EC135 at all. Consequently it was decided that the cause of the Airprox was a late sighting by the EC135 pilot and a non-sighting by the C172 pilot. The Board then turned its attention to the risk. The Board opined that although the EC135 pilot had taken avoiding action to prevent a collision, safety margins had been much reduced below the normal because the two aircraft had passed 0.1nm apart at a similar altitude. Consequently the Airprox was categorised as risk Category B.

Cause: A late sighting by the EC135 pilot and a non-sighting by the C172 pilot.
