AIRPROX REPORT No 2015100

Date: 2 Jul 2015 Time: 1455Z Position: 5305N 00018W Location: 3nm NE Coningsby

PART A: SUMMARY OF INFORMATION REPORTED TO UKAB

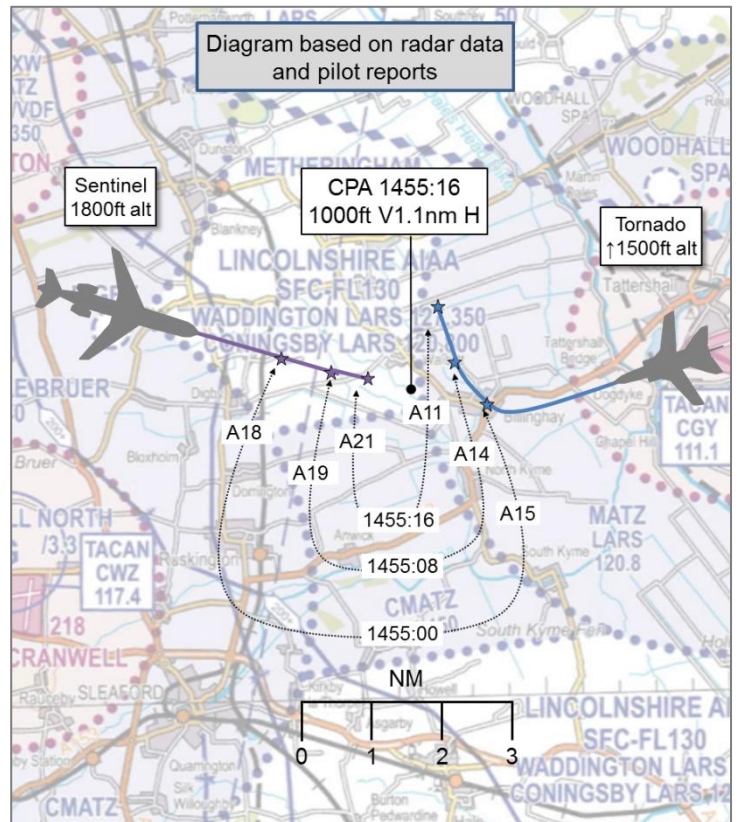
In looking at the cause of the Airprox, the Board quickly agreed that it was that Coningsby ATC had allowed the Tornado to depart into conflict with the Sentinel. Nevertheless, the actions taken by the pilots had been timely and effective, and so the risk was assessed as Category C.

Cause: Coningsby ATC allowed the Tornado to depart into conflict with the Sentinel.
