AIRPROX REPORT No 2015111

Date: 14 Jul 2015 Time: 1815Z Position: 5230N 00236E Location: BARMI

PART A: SUMMARY OF INFORMATION REPORTED TO UKAB

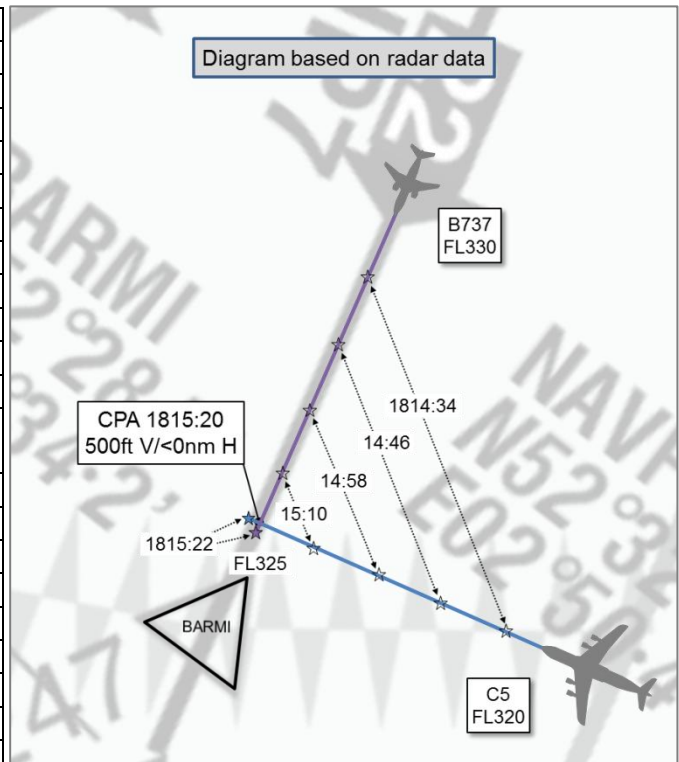
Recorded	Aircraft 1	Aircraft 2
Aircraft	B737	C5
Operator	CAT	Foreign Mil
Airspace	UAR	UAR
Class	C	C
Rules	IFR	IFR
Service	Radar Control	Radar Control
Provider	Swanwick	Swanwick
Altitude/FL	FL325	FL320
Transponder	A/C/S	A/C/S
Reported		
Colours	White/blue	Grey
Lighting	NK	Strobes, nav, leading edge and fuselage
Conditions	NK	VMC
Visibility	NK	>20nm
Altitude/FL	NK	FL320
Heading	NK	NK
Speed	NK	NK
ACAS/TAS	TCAS II	TCAS II
Alert	RA	RA
Separation		
Reported	600ft V/NK H	500ft V/0m H
Recorded	500ft V/<0.1nm H

THE BOEING 737 PILOT reports that whilst at FL340, and well before waypoint BARMI, he received a clearance to be level at FL300 at BARMI. A short while afterwards, he was then issued with an instruction to leave FL340 for FL330. As the First Officer entered the flight deck after a short visit to the restroom, he realized that they were close to BARMI and that he was high on the profile to meet the previous clearance to be level at FL300 at BARMI. He increased the rate of descent and, just below FL330; they received a TCAS TA and then an RA. He responded manually and adjusted pitch to follow the RA instructions; at that moment he gained visual contact with the conflicting traffic, observing it passing behind them. After a short communication with ATC he realized that his cleared level was FL330.

THE LOCKHEED C5 GALAXY PILOT reports that both pilots at the controls of the C5 were following the B737 via TCAS and picked it up visually on their right-hand side, 1000ft above and slowly converging; visual contact was made initially at approximately 15nm. As the B737 approached overhead it initiated a rapid descent. With approximately 800ft of vertical separation, the First Pilot at the primary controls in the right seat disengaged the autopilot and also began a descent. The Instructor Pilot, in the left seat, followed on the controls and immediately notified Swanwick Mil [he thought] of their deviation while following the RA. Because the B737 was directly overhead, visual contact was not maintained during the response to the RA. They descended to approximately FL314 before the RA cleared. Indications in their cockpit placed the B737 within 500ft of their aircraft, and its pilot appeared to have descended near, or to, their cleared FL (FL320). No traffic calls were given by Swanwick prior to the response to the RA. Due to the other aircraft's pilot communicating on a different frequency [he recollected] they were unaware of any clearances he had been given.
