AIRPROX REPORT No 2015134

Date: 29 Jul 2015 Time: 1328Z Position: 5426N 00058W Location: 17nm ESE Newcastle

PART A: SUMMARY OF INFORMATION REPORTED TO UKAB

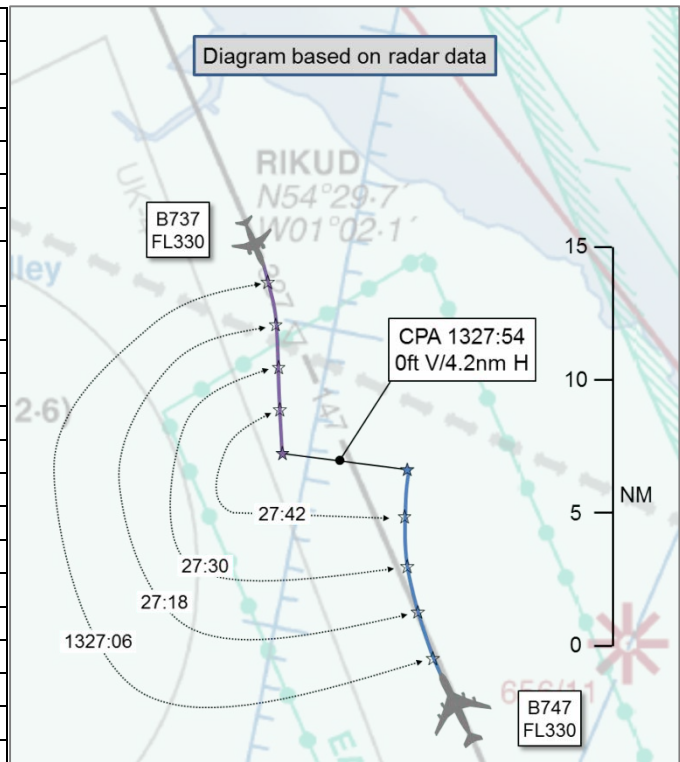
Recorded	Aircraft 1	Aircraft 2
Aircraft	B737	B747
Operator	CAT	CAT
Airspace	UAR	UAR
Class	C	C
Rules	IFR	IFR
Service	Radar Control	Radar Control
Provider	Montrose Sector	Montrose Sector
Altitude/FL	FL330	FL330
Transponder	A,C,S	A,C,S
Reported		
Colours	Grey/red	White/blue
Lighting	Strobes, nav	NK
Conditions	VMC	VMC
Visibility	>10km	'good'
Altitude/FL	FL330	FL330
Heading	NK	NK
Speed	NK	NK
ACAS/TAS	TCAS II	TCAS II
Alert	TA	Nil
Separation		
Reported	NK	NK
Recorded	0ft V/4.2nm H
