AIRPROX REPORT No 2015138

Date: 15 Aug 2015 Time: 1656Z Position: 5117N 00009W Location: M25 N abeam Redhill

PART A: SUMMARY OF INFORMATION REPORTED TO UKAB

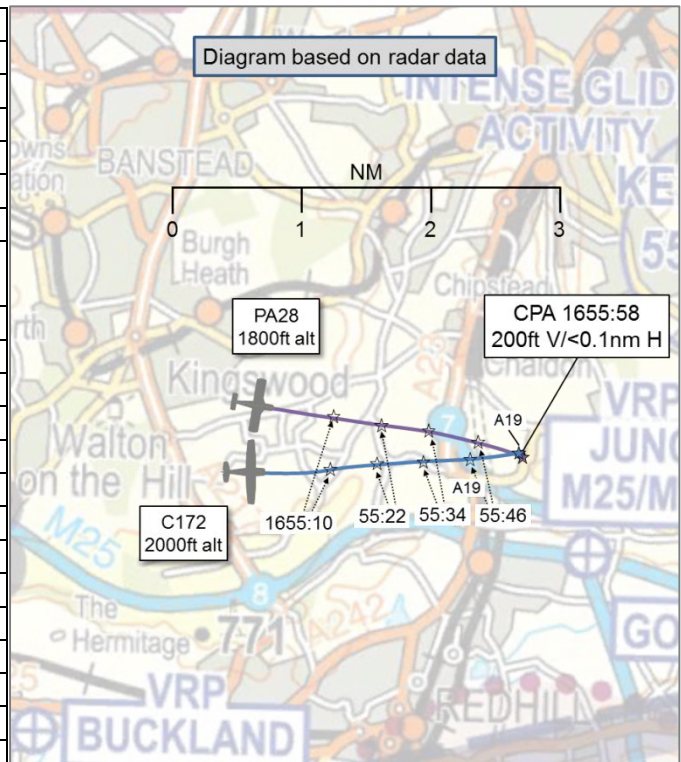
THE CESSNA 172 PILOT reports being inbound to Biggin Hill. He first saw the other aircraft between 100-150ft away. It was approaching slightly behind, to his left and approximately 50ft below. It passed directly underneath, heading about 090°-100°. He reported ‘pulling up’ as avoiding action.

Figures 2 and Figure 3 show two consecutive Radar sweeps made at 1655:50 and 1655:56 respectively. The CPA occurred at Figure 3, when the aircraft were less than 0.1nm horizontally and 100ft vertically apart. There was no mention of the event on the radio and Biggin Hill were not aware that an Airprox had occurred.
