AIRPROX REPORT No 2015180

Date: 9 Oct 2015 Time: 1635Z Position: 5110N 00040W Location: 5nm SW Guildford

PART A: SUMMARY OF INFORMATION REPORTED TO UKAB

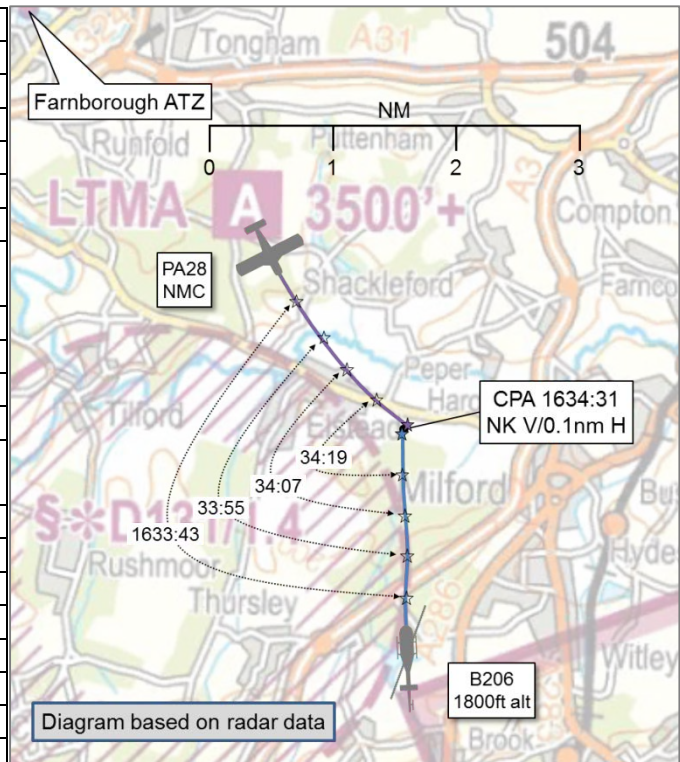
Recorded	Aircraft 1	Aircraft 2
Aircraft	B206	PA28
Operator	Civ Pte	Civ Club
Airspace	London FIR	London FIR
Class	G	G
Rules	VFR	VFR
Service	Basic	Basic
Provider	Farnborough LARS(W)	Farnborough LARS(W)
Altitude/FL	1800ft	NMC
Transponder	A, C, S	A, S
Reported		Not reported
Colours	Blue/grey	
Lighting	Beacon, strobes, HISL	
Conditions	VMC	
Visibility	>10km	
Altitude/FL	1800ft	
Altimeter	QNH (1021hPa)	
Heading	360°	
Speed	112kt	
ACAS/TAS	TAS	
Alert	TA	
Separation		
Reported	<50ft V/ <500m H	
Recorded	NK V/0.1nm (185m) H

THE B206 PILOT reports heading north to his destination in clear weather with good visibility and light winds. When about 5nm southwest of Guildford, he saw a red hot-air balloon landing to the northwest of Godalming. He also noticed a traffic indication ‘without relative altitude’ on his TAS at a location close to that of the hot-air balloon. About 30sec later, the TAS issued an audio warning (warning threshold was set at 2nm). He kept ‘a sharp look out’ to the left 10-11 o’clock. Shortly after, at a range of less than 1nm, a white and dark coloured PA28 appeared from about 30° left of the nose on an estimated bearing of about 320-330° and at the same altitude. The B206 pilot made a sharp climbing turn to the left, towards west, and the pilot of the other aircraft also turned left, towards east. The B206 pilot noted that he could see the logo on the fin of the PA28.
