AIRPROX REPORT No 2015197

Date: 27 Oct 2015 Time: 0936Z Position: 5815N 00257W Location: 15nm SSE Wick

PART A: SUMMARY OF INFORMATION REPORTED TO UKAB

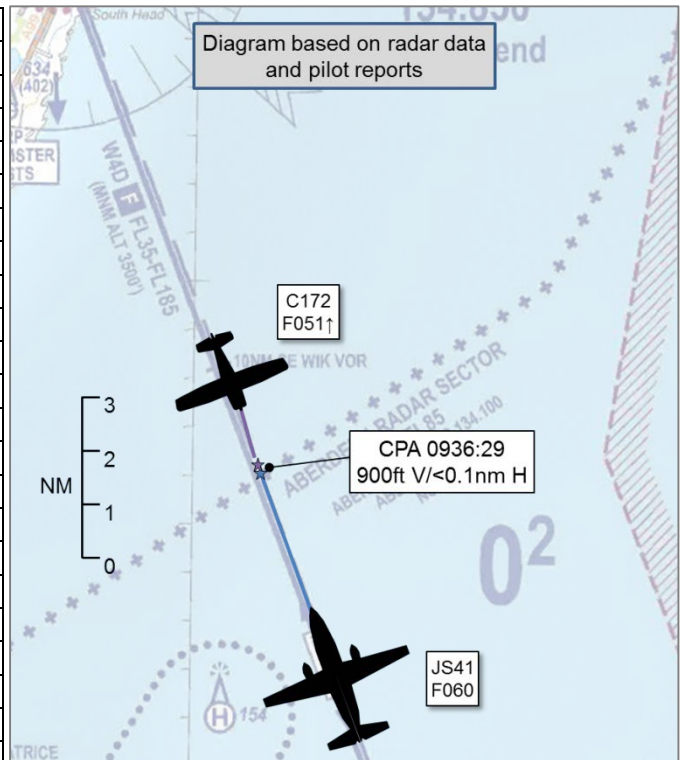
Recorded	Aircraft 1	Aircraft 2
Aircraft	JS41	C172
Operator	CAT	Civ Pte
Airspace	Scottish FIR	Scottish FIR
Class	G	G
Rules	IFR	IFR
Service	Procedural	Procedural
Provider	Wick	Wick
Altitude/FL	FL060	FL051
Transponder	A, C, S	A, C
Reported		
Colours	NK	NK
Lighting	NK	Strobe, Nav
Conditions	VMC	IMC
Visibility	10KM	NK
Altitude/FL	FL060	NK
Altimeter	QNH (1013hPa)	NK
Heading	NK	NK
Speed	210kt	NK
ACAS/TAS	TCAS II	Unknown
Alert	Proximate	Unknown
Separation		
Reported	NK	NK
Recorded	900ft V/<0.1nm H

THE WICK CONTROLLER reports that he was an OJTI instructing with a student ATCO controlling. The C172 was routing on track ADN on the 162 radial from Wick, SE-bound, climbing to FL70. The JS41 was pre-noted for an ETA 16min after the C172 departed; inbound to Wick on the 162R. The C172 was instructed to climb FL50 and later told to report maintaining FL50, both transmissions were acknowledged. The JS41 was given a descent to FL60 to effect a procedural separation against the C172, and Traffic Information was given to each ac on the other. The C172 was asked to report his position, at which point he gave his range as 12DME outbound and also, fortunately, gave his level information as passing 5200ft. The OJTI stepped in and instructed the ac to "descend to FL50, altitude five thousand feet QNH1013" and essential Traffic Information was passed to the JS41 who reported at range 15DME inbound. The JS41 reported on the ground that no TCAS event had occurred and the C172 did not come closer than 900ft vertically.
