AIRPROX REPORT No 2014121

Date/Time: 21 Jul 2014 1426Z

Position: 5302N 00026W
(RAF Cranwell)

Airspace: Cranwell ATZ (Class: G)

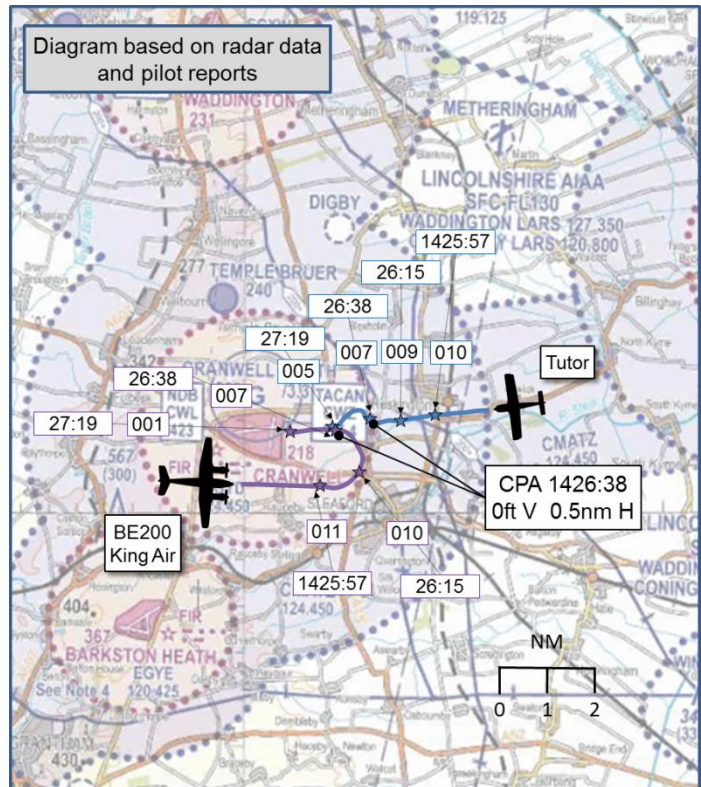
Reported Separation:
0ft V/750m H 200ft V/800m H

Recorded Separation:
0ft V/0.5nm H

Cause: The King Air pilot flew into conflict with the Tutor.

Recommendation: The MAA reviews the provision of Aerodrome Control Service at military airfields.
