AIRPROX REPORT No 2014133

Date/Time: 3 Aug 2014 1114Z (Sunday)

Position: 5129N 00020E
(3.5nm SSW of Thurrock)

Type: Fournier RF5 PA28
Motorglider

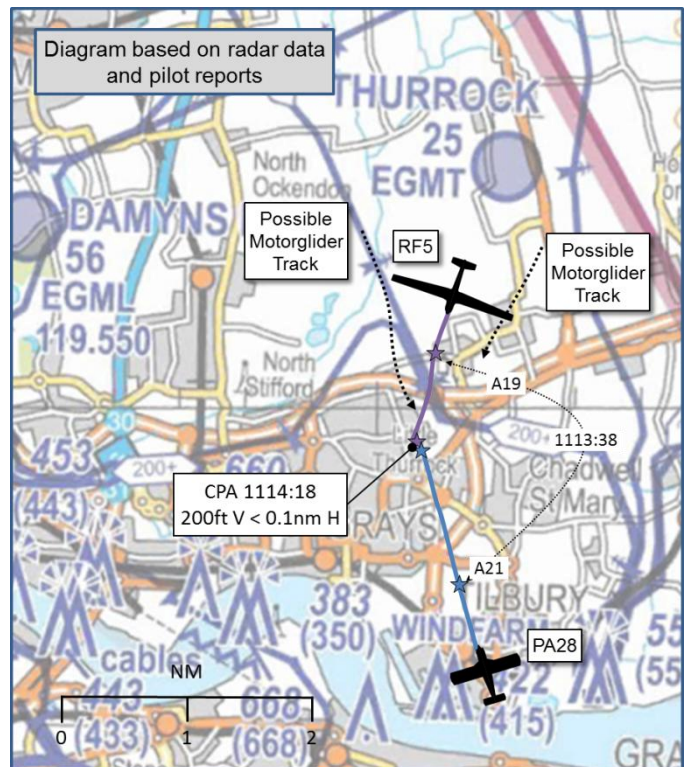
Recorded Separation:
200ft V/<0.1nm H

| <u>Cause:</u> | A late sighting by the RF5 pilot and effectively a non-sighting by the PA28 pilot. |

| <u>Recommendation(s):</u> | GASCO considers ways of improving pilots' understanding of Radio Mandatory Zones. |
