AIRPROX REPORT No 2014166Date/Time: 29 Aug 2014 1254ZPosition: 5142N 00108W
(1nm E Oxford)Airspace: Oxford AIAA (Class: G)Aircraft 1 Aircraft 2Type: Tutor Rockwell 695
Jet prop 1000Operator: HQ Air (Trg) Civ ExecAlt/FL: 4000ft FL45
NKConditions: VMC VMCVisibility: 10km 10kmReported Separation:

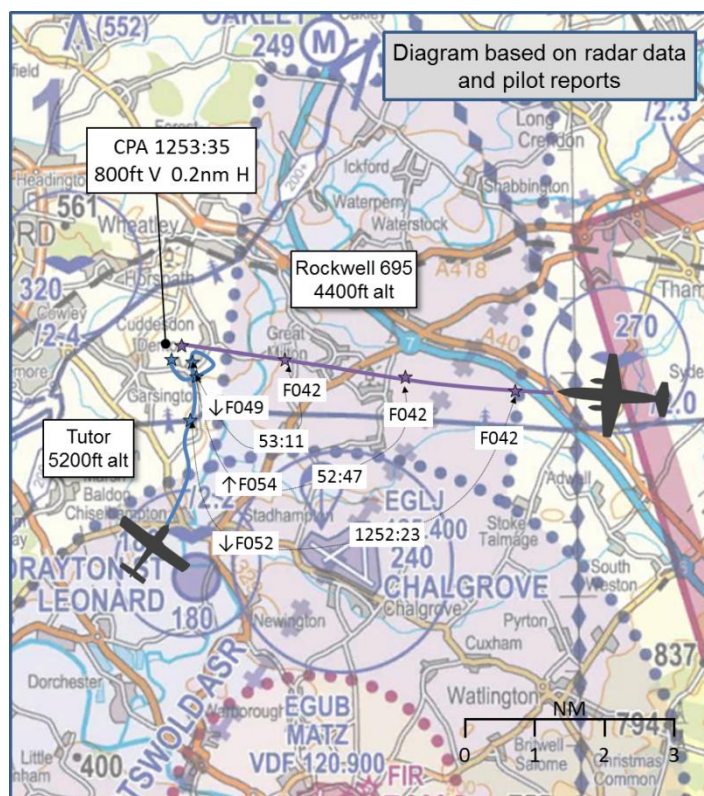
150ft V/100m H

800ft V/0.2nm H

The Board assessed the cause of the Airprox to be a non-sighting by the Tutor pilot and a late sighting by the Rockwell pilot, with a contributory factor of a lack of Traffic Information to the Tutor pilot and inaccurate Traffic Information to the Rockwell pilot. Notwithstanding, the aircraft did achieve 800ft separation at CPA and so the risk was assessed as Category C, effective and timely actions had been taken to prevent the aircraft colliding.
