AIRPROX REPORT No 2014217

Date/Time: 11 Nov 2014 1633Z (Twilight)¹

Position: 5136N 00001W
(RAF Benson – elevation 203ft)

Reporter: RAF Benson Aerodrome Controller

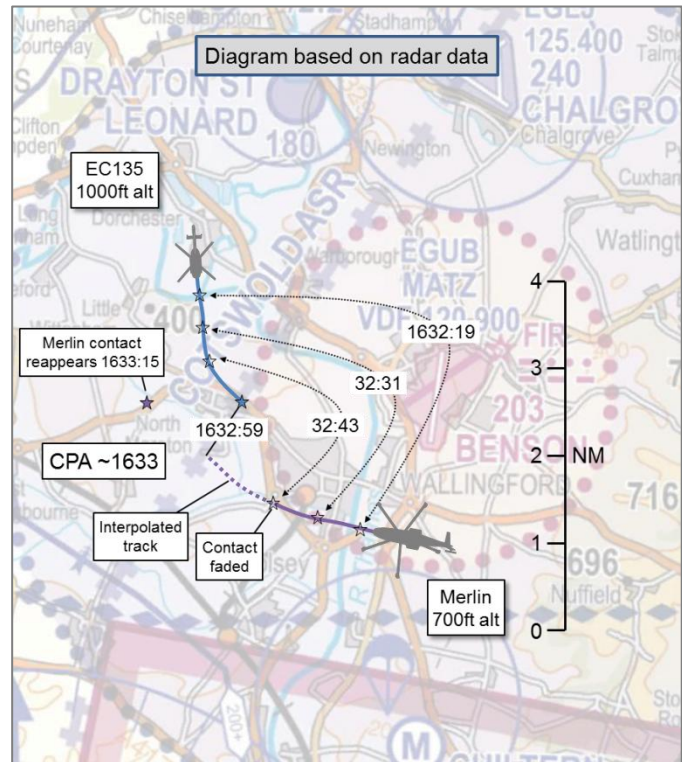
<u>Cause:</u>	The Merlin pilot departed the visual circuit, contrary to his stated intentions, and flew into conflict with the EC135.
<u>Degree of Risk:</u>	C.
<u>ERC Score</u> ⁵ :	2.
