AIRPROX REPORT No 2013051

Date/Time: 16 Jun 2013 1258Z (Sunday)

Position: 5131N 00014E
(1.7nm NE of Damyns Hall A/D
- elevation 56ft)

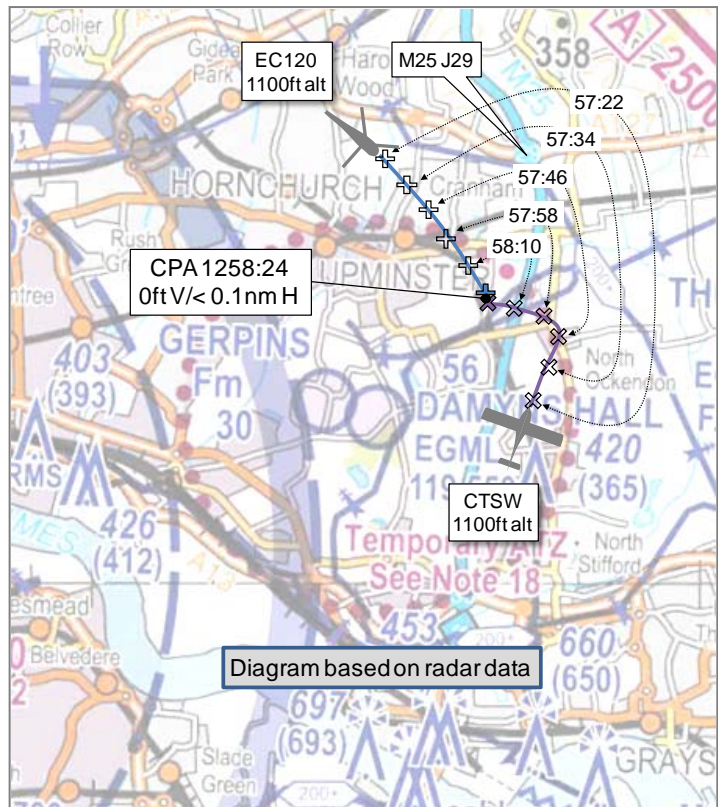
0ft V/0.1nm H

The Airprox occurred in Class G uncontrolled airspace, 1.7nm NE of Damyns Hall Aerodrome. The minimum recorded distance between the two ac was 0ft vertical and 0.1nm horizontal. Although the EC120B was in receipt of a BS, in Class G airspace, collision avoidance rests solely with the pilots of both ac. They did obtain visual contact with the other ac and signalled accordingly. However, it would appear that, while the pilot of the EC120B observed the CTSW pilot wagging his wings, the pilot of the latter ac was unaware, at the time, whether or not the helicopter pilot had spotted his ac.

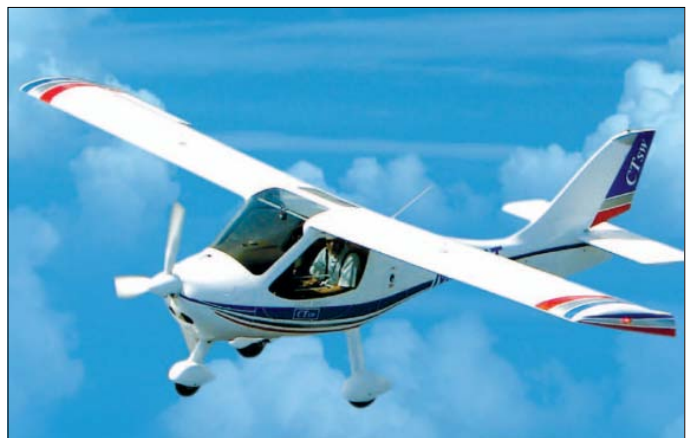
THE CTSW PILOT reports that navigation lights, beacon and landing lights were illuminated. He was carrying out cct training on RW21, left-hand, at Damyns Hall, with a student handling the ac. While on the late downwind leg (he thought) at 1000ft he observed a helicopter in his 2 o'clock, about 1km away, at the same level. As the student turned L onto base leg (heading 300°) at 1000ft he noticed that the helicopter was still in his 2 o'clock, on a collision course, about 300m away. He took control from the student, waggled his wings and turned L onto final approach for RW21. He commented that there was no sign whether or not the helicopter pilot had seen his ac. The helicopter pilot was not on the Damyns Hall A/G frequency.

He assessed the risk of collision as 'High'.
