AIRPROX REPORT No 2013141

Date/Time: 23 Sep 2013 1424Z

Position: 5712N 00212W
(Aberdeen Airport
-elevation 215ft)

Airspace: Aberdeen CTR (Class: D)

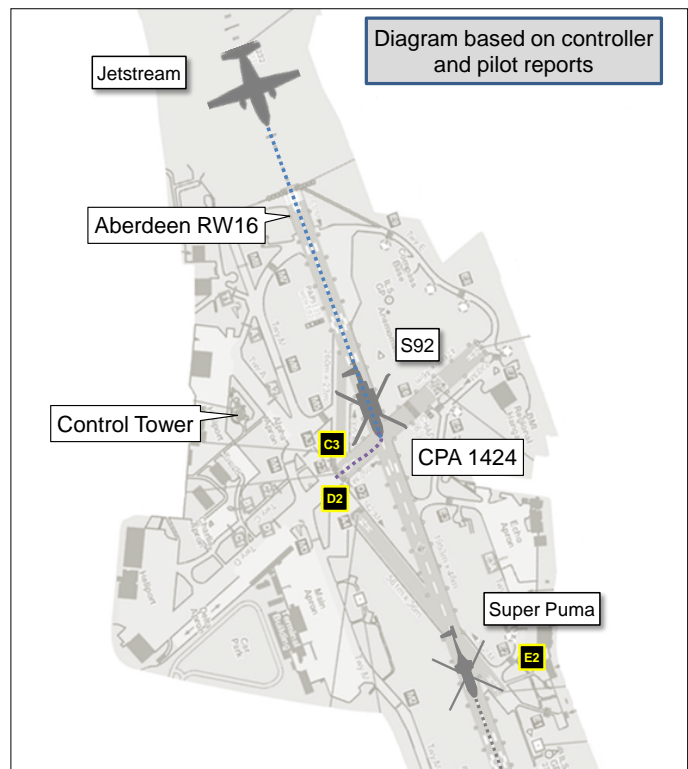
THE JS41 (JETSTREAM) PILOT reports inbound IFR to Aberdeen airport (ABZ). Strobes, landing lights and wing conspicuity lights were illuminated; SSR Mode C was selected. He was being vectored to land on RW16. He was turned onto base-leg about 10nm from the runway and further cleared for the ILS approach to RW16. On the glide-slope he was advised that RW32 was available to vacate the runway, but no landing clearance was given. At 4nm he was instructed to reduce to minimum safe approach speed. The Aerodrome controller then asked a helicopter pilot if he was ready for an immediate departure. Receiving confirmation, the helicopter pilot was instructed to enter RW16 into the hover. At this point he could clearly see this helicopter towards the far end of the runway. The Jetstream pilot was advised that it would be a late landing clearance. He watched the helicopter climb away and his landing clearance followed. He was 100ft above decision at this time, 300ft above ground. At decision height/altitude he elected to land. At this point, on the threshold of RW16, its presence unknown to him, another helicopter became visible when it turned 90° in the hover and the fuselage markings became visible. He reported the first sighting distance as 400yd. Until the helicopter turned it was not visible on the runway as it blended in with the black rubber lines on the threshold and his focus was more on the departing helicopter at the far end of the runway. He immediately called going around and asked the First Officer (FO) to advise the Tower. He was never instructed by the Aerodrome controller to initiate a go-around. He did not know how close he came to a collision with the helicopter. As he climbed away on the standard missed approach (straight ahead, climbing to 3000ft) he became aware of catching up the previously departing helicopter and advised the FO that he would be turning right to avoid a collision with this helicopter. At this point he still had no communication with the Aerodrome controller. Finally, he was advised to contact radar and he immediately told the FO to make contact as a priority whilst he was maintaining visual separation with the helicopter climbing away. Advised to turn right 270° to avoid, the FO had to ask if he was to climb to 3000ft as nobody had said anything different. The answer was yes, and to take up the hold at the VOR whilst ATC figured out what had happened. He went twice round the hold before being vectored back to normal landing. He was positive that no communication took place between the helicopter on the threshold and the Aerodrome controller, the only aircraft he could think of was a preceding landing aircraft and the departing helicopter. He reiterated that after the go-around no instructions were issued to avoid the departing helicopter.

THE S92 PILOT reports outbound, VFR, [in fact ATC issued an IFR clearance] from ABZ. SSR Mode C was selected. He was holding at 'C3'. He believed that he received a clearance to 'Line up 16, lift into the hover, be ready immediate'. The Co-pilot acknowledged the clearance and confirmed that the stop-lights were clear. As he lined up, in the hover, both pilots were surprised to see another helicopter lined up further down the runway, abeam 'E2'. He commented about this, wondering if the controller was trying to get both helicopters airborne. The helicopter ahead departed, leaving him in the hover awaiting take-off clearance. He then heard an aircraft cleared to land. He commented that it is not uncommon for helicopters to be given clearance to land with others further down the runway, but, given that he was expecting an immediate clearance, something did not seem quite right. He turned the aircraft 90° to look behind and spotted a fixed-wing aircraft on short final. He called to the co-pilot 'fixed wing' and immediately vacated the runway, landing at 'D2'. As he carried this out, the fixed-wing aircraft called "going-around". He was unsure of the range and separation between his helicopter and the Jetstream, as it happened so quickly. He just glanced at the approach and saw the fixed-wing aircraft and vacated immediately. His lighting was the standard navigation and anti-collision lights. He did not think the lights were an issue, as it was CAVOK. The helicopter was equipped with TCAS but it is disabled on the ground (weight on wheels), so he was not in the habit of looking at it as he lined up. Albeit the helicopter was in the hover, it was essentially a ground movement. He did not recall receiving a TCAS alert, but even if he did, he would have assumed it was from the helicopter lined up ahead. He pointed out that on the EC225, the approaching aircraft could be seen on TCAS, whilst waiting at the holding point and this also applied on an oil-rig; this is not possible on the S92. He had been advised that it is illegal to operate TCAS on the ground.

- The Aerodrome Controller had left the 'C3' stop-bar lights off after another aircraft had lined up before the S92, and the S92 pilot interpreted their absence as corroborating his impression that it was he who had been cleared to line up.

When discussing the cause of the Airprox, the Board quickly decided that the main factor was that the S92 pilot, albeit unintentionally, entered the runway without a clearance. A contributory factor was that the Aerodrome controller had forgotten to select the stop-bar at 'C3' after a previous departure. Several members and advisors wondered why the runway stop-bars at ABZ were not equipped with automatic 'time-out', which would result in them returning to the closed position after a selected time interval without controller interaction. Consequently, it was considered that a recommendation should be made to Aberdeen airport to consider the fitment of stop-bar 'auto-timeout' functionality. The Board also opined that a further contributory factor was that the controller had not seen the S92 on the runway when clearing the Jetstream pilot to land.

| <u>Recommendation:</u> | Aberdeen airport considers the fitment of stop-bar 'auto-timeout' functionality. |
