## AIRPROX REPORT No 2013161

Date/Time: 21 Nov 2013 0815Z

Position: 5130N 00049W  
(10nm W Heathrow airport)

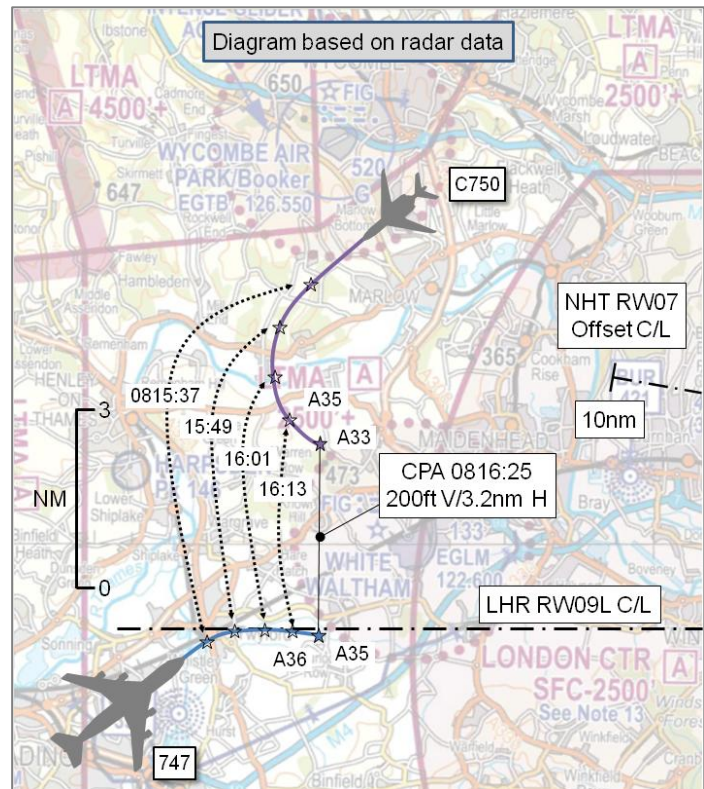
Reported Separation:  
0ft V/4nm H                      0ft V/3nm H

Recorded Separation:  
200ft V/3.2nm H

**THE LHR FINAL (FIN) DIRECTOR (DIR)** reports that he observed the C750, which was inbound to NHT, go through the off-set centre-line for RW07 at NHT in the descent to 3000ft. This created a conflict with the B747, which was established on the Localiser RW09L at 4000ft and cleared for descent with the glide path. Avoiding action was issued to the B747 pilot to break-off the approach and turn right heading 150°. This instruction was correctly read-back and complied with. Traffic

Information was passed, and he believed that standard separation was maintained. Once the C750 was observed to have turned back towards NHT and out of conflict with the RW09L approach, the B747 pilot was turned back to establish ILS RW09L again and the aircraft completed its approach.
