AIRPROX REPORT No 2012138

Date/Time: 29 Aug 2012 1003Z

Position: 5425N 00102W
(19nm ENE Leeming)

Airspace: Vale of York AIAA (Class: G)

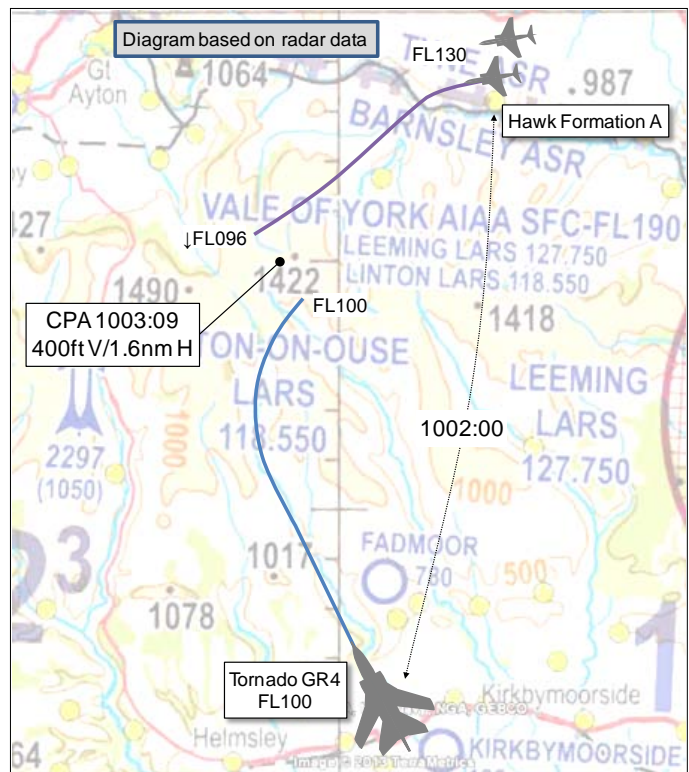
0ft V/3.4nm H
400ft V/1.6nm H

At 1002:22, Controller 2 asked whether Leeming was, "able to stop his [the Hawk formation's] descent not below Flight Level 1-1-0?" and the Leeming SUP replied, "no, it's already in the descent to Flight Level 5-0 now." At this point the SSR Mode C of the Hawk formation leader could be observed on the NATS radar replay to be indicating descent through FL115. This mirrors the report by the Leeming SUP who stated that their decision that 'there was not enough time available to instruct DIR to advise [Hawk Formation A] to stop descent at FL110' was based on observing the SSR Mode C of the formation indicating descent through FL115. This suggests that there was a good correlation between the SSR Mode C presented to the 2 units, potentially as a result of the Hawk formation's benign ROD (radar replay shows approximately 3000fpm, which is in-line with Hawk SOPs for a formation descent in IMC).

At 1002:50 the turn by the GR4 becomes evident on radar and, at 1002:53, DIR issued avoiding action to the Hawk formation instructing them to, "*turn right heading 2-7-0 degrees, traffic was left 11 o'clock, 4 miles, tracking east, Flight Level 100*" which was acknowledged. The GR4 was 4.3nm SSW of the Hawk formation, turning through N; the SSR Mode C of the Hawk formation leader could be observed on the NATS radar replay to be indicating descent through FL101. At 1002:55, Controller 2 amended the avoiding action to the GR4 pilot, instructing them to, "*turn right immediately heading 1-0-0 degrees now, traffic was north, 3 miles, tracking south-east, Flight Level 100, descending*" which was correctly read-back. Whilst Controller 2 incorrectly described the Hawk formation's direction of travel as "*south-east*", this was neither a causal nor a contributory factor in this Airprox.
