AIRPROX REPORT No 2022004

Date: 20 Jan 2022 Time: 1052Z Position: 5247N 00246W Location: 4NM west of Shawbury

PART A: SUMMARY OF INFORMATION REPORTED TO UKAB

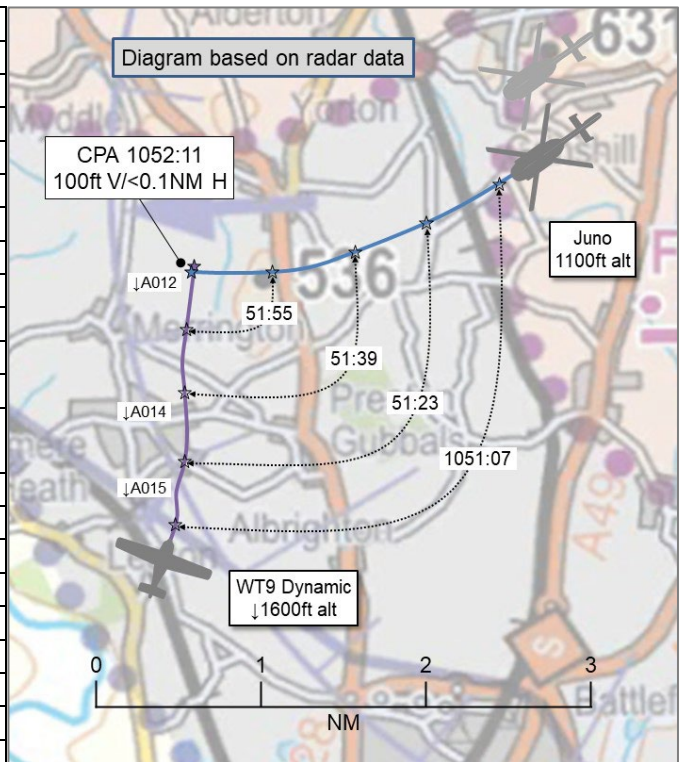
Recorded	Aircraft 1	Aircraft 2
Aircraft	Juno	WT9 Dynamic
Operator	HQ Air (Ops)	Civ FW
Airspace	Shawbury MATZ	Shawbury MATZ
Class	G	G
Rules	VFR	VFR
Service	Basic	Establ'ing contact
Provider	Shawbury LL	Shawbury Zone
Altitude/FL	1100ft	1200ft
Transponder	A, C, S	A, C, S
Reported		
Colours	Black, yellow	White
Lighting	HISLs, strobes, nav, landing light	Strobes
Conditions	VMC	VMC
Visibility	>10km	>10km
Altitude/FL	1000ft	1500ft
Altimeter	QFE (1030hPa)	QNH (1033hPa)
Heading	260°	NR
Speed	90kt	NR
ACAS/TAS	TAS	Not fitted
Alert	None	N/A
Separation at CPA		
Reported	50ft V/50m H	20ft V/100m H
Recorded	100ft V/<0.1NM H

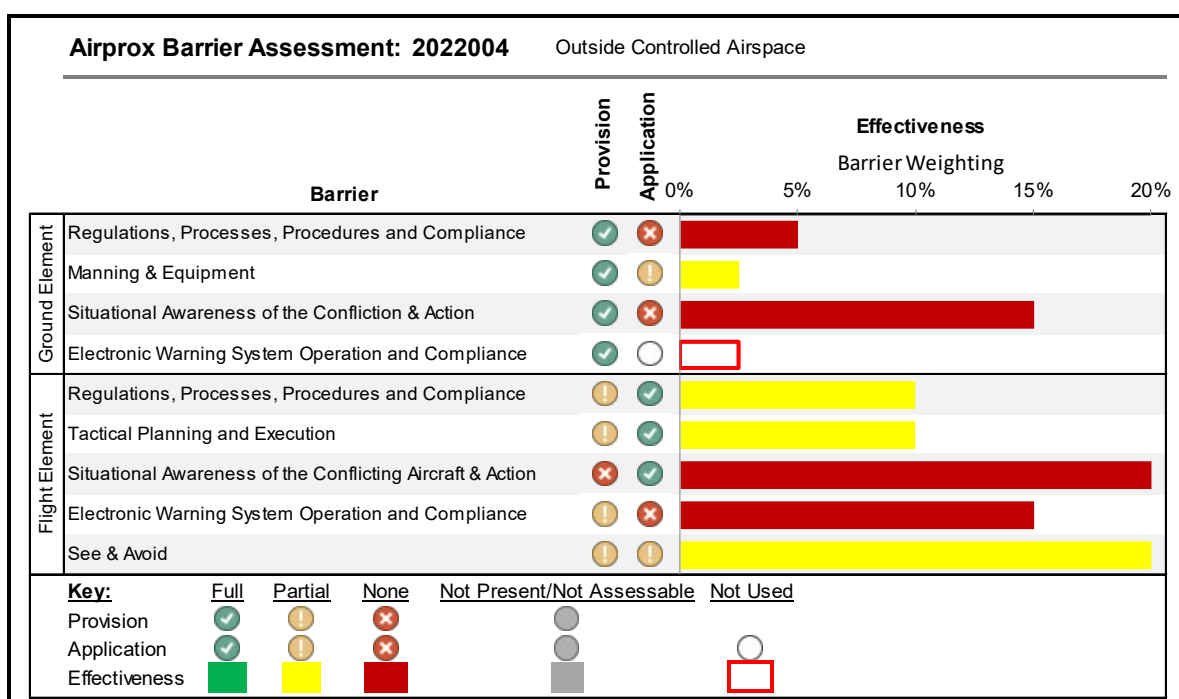
Electronic Warning System Operation and Compliance were assessed as **ineffective** because the TAS on the Juno did not provide an alert of the presence of the WT9.

See and Avoid were assessed as **partially effective** because the Juno pilot did not see the WT9 and the WT9 pilot only saw the Juno formation at a late stage, requiring immediate action to increase separation.
