AIRPROX REPORT No 2022002

Date: 12 Jan 2022 Time: 1120Z Position: 5155N 00211W Location: Gloucestershire

PART A: SUMMARY OF INFORMATION REPORTED TO UKAB

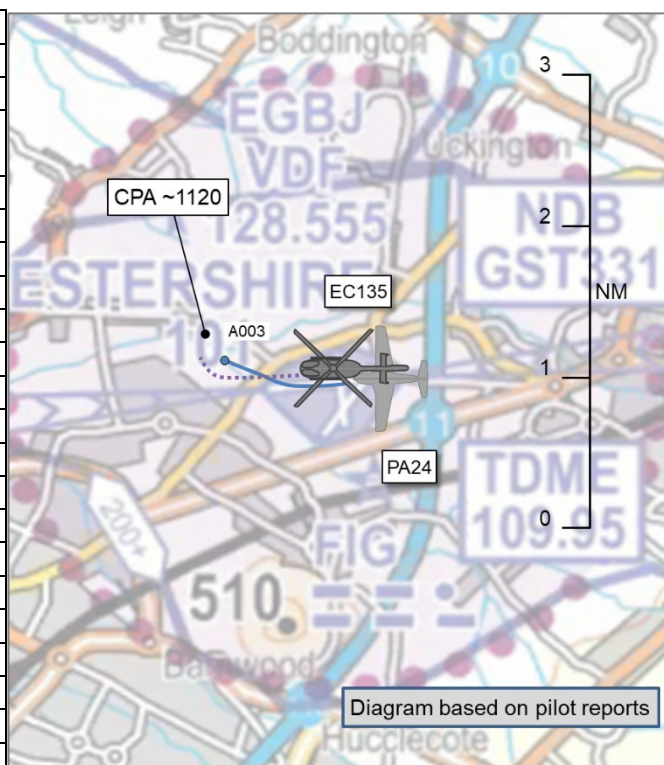
Recorded	Aircraft 1	Aircraft 2
Aircraft	PA24	EC135
Operator	Civ FW	Civ Helo
Airspace	Gloucestershire ATZ	Gloucestershire ATZ
Class	G	G
Rules	VFR	VFR
Service	ACS	ACS
Provider	Gloster	Gloster
Altitude/FL	300ft	NK
Transponder	A, C ¹ , S	A, C, S
Reported		
Colours	Red, White	Red
Lighting	Beacon	'Full'
Conditions	VMC	VMC
Visibility	>10km	>10km
Altitude/FL	500ft	700ft
Altimeter	QNH	QNH
Heading	300°	360°
Speed	90kt	100kt
ACAS/TAS	Not fitted	TAS
Alert	N/A	None
Separation at CPA		
Reported	0ft V/500ft H	Not Seen
Recorded	NK

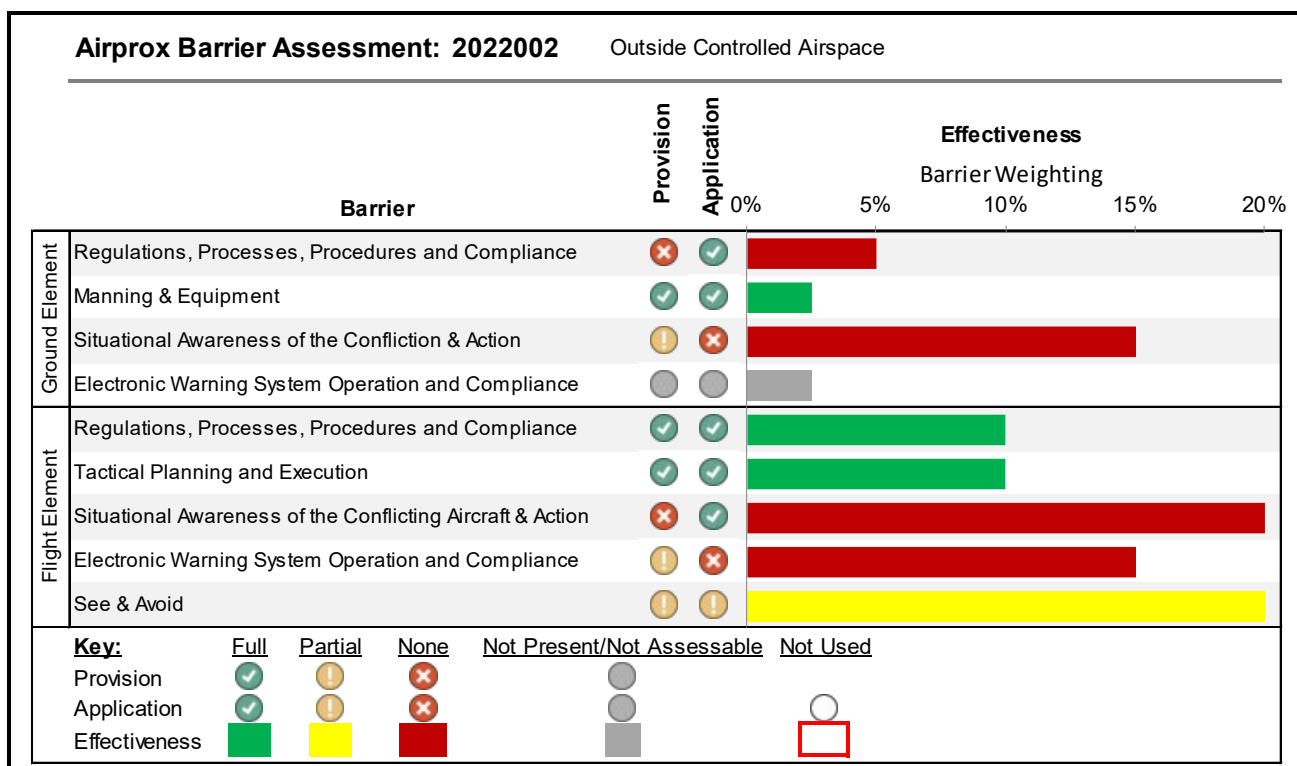
Electronic Warning System Operation and Compliance were assessed as **ineffective** because the TAS in the EC135 was reported as not alerting, when an alert would be expected.

See and Avoid were assessed as **partially effective** because the PA24 pilot was able to take avoiding action.
