## AIRPROX REPORT No 2022010

Date: 10 Feb 2022 Time: 1344Z Position: 5416N 00113W Location: 2.5NM N Sutton Bank

### PART A: SUMMARY OF INFORMATION REPORTED TO UKAB

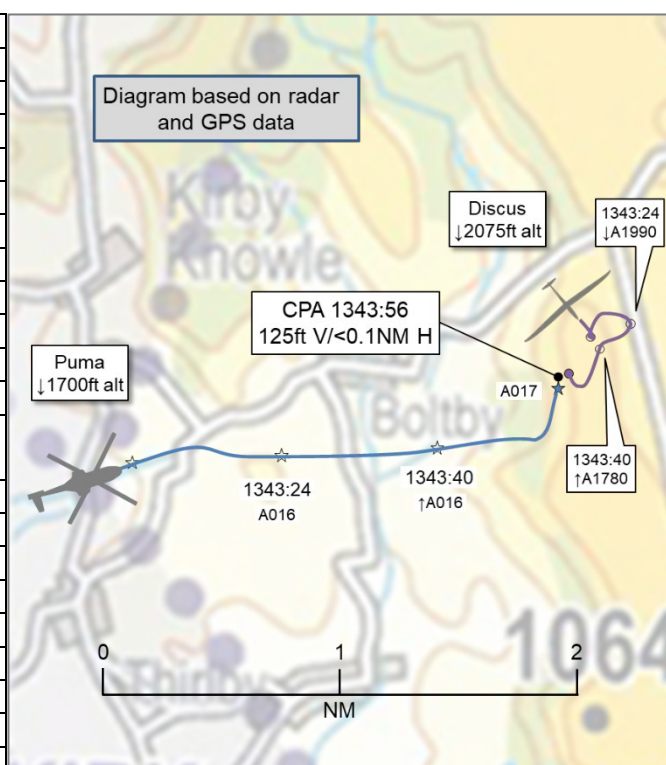
Recorded	Aircraft 1	Aircraft 2
Aircraft	Puma	Discus
Operator	HQ JHC	Civ Gld
Airspace	London FIR	London FIR
Class	G	G
Rules	VFR	VFR
Service	Basic	Listening Out
Provider	Leeming Approach	Sutton Bank
Altitude/FL	1700ft	1825ft
Transponder	A, C, S	Not fitted
Reported		
Colours	Green	White
Lighting	Nav, Strobe, Landing	None
Conditions	VMC	VMC
Visibility	>10km	>10km
Altitude/FL	1500FT	1700ft
Altimeter	QNH (1022hPa)	QNH (NK hPa)
Heading	090°	270°
Speed	NR	60kt
ACAS/TAS	TAS	FLARM
Alert	None	None
Separation at CPA		
Reported	NR V/75m H	200ft V/100m H
Recorded	125ft V/<0.1NM H

The sequence of events was found to be as reported. Although the GPX file showed minor variation in the reported altitudes and sequence of turns (i.e. inputs), the lag on the system and the unverified nature of the information makes it advisory only. Regardless, none of the GPX data contradicts or changes the narrative of events to any significance.
