AIRPROX REPORT No 2022012

Date: 10 Feb 2022 Time: 1447Z Position: 5052N 00043W Location: Chichester/Goodwood circuit

PART A: SUMMARY OF INFORMATION REPORTED TO UKAB

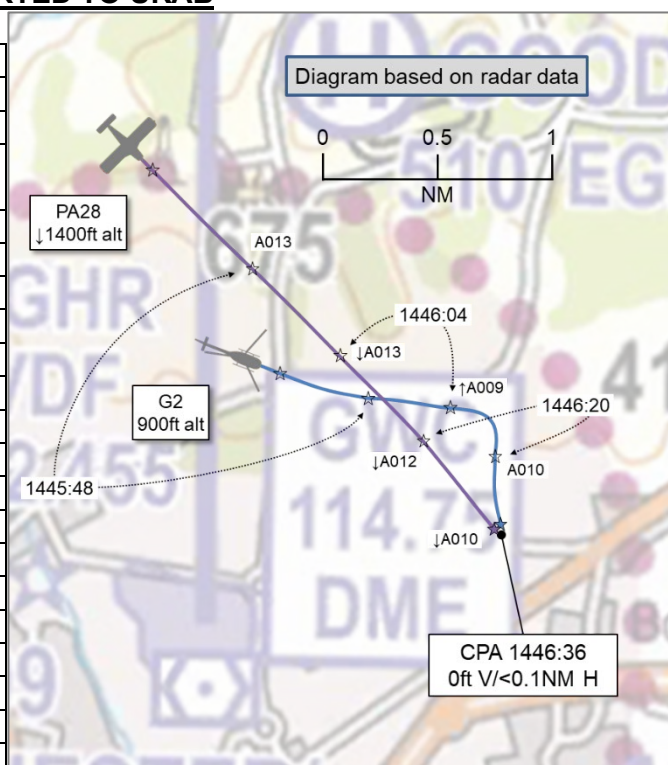
Recorded	Aircraft 1	Aircraft 2
Aircraft	Cabri G2	PA28
Operator	Civ Helo	Civ FW
Airspace	Chichester/ Goodwood ATZ	Chichester/ Goodwood ATZ
Class	G	G
Rules	VFR	VFR
Service	AFIS	AFIS
Provider	Goodwood Info	Goodwood Info
Altitude/FL	1000ft	1000ft
Transponder	A, C, S	A, C, S +
Reported		
Colours	White, Grey	White
Lighting	Strobe, Landing	Landing
Conditions	VMC	VMC
Visibility	>10km	>10km
Altitude/FL	900ft	900ft
Altimeter	QFE (1019hPa)	QFE (1021hPa)
Heading	140°	140°
Speed	75-80kt	105kt
ACAS/TAS	Not fitted	Not fitted
Separation at CPA		
Reported	0 V/15m H	0ft V/15-20m H
Recorded	0ft V/<0.1NM H

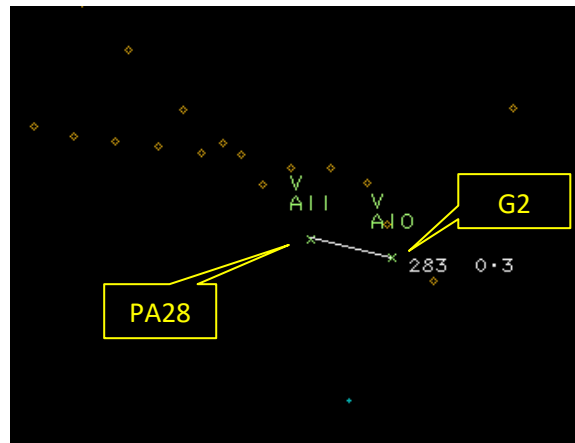
Figure 5 – 1446:22

At **1446:20** the FISO responded to a pilot reporting downwind.
