AIRPROX REPORT No 2022013

Date: 05 Jan 2022 Time: ~1302Z Position: 5215N 00253W Location: Shobdon circuit

PART A: SUMMARY OF INFORMATION REPORTED TO UKAB

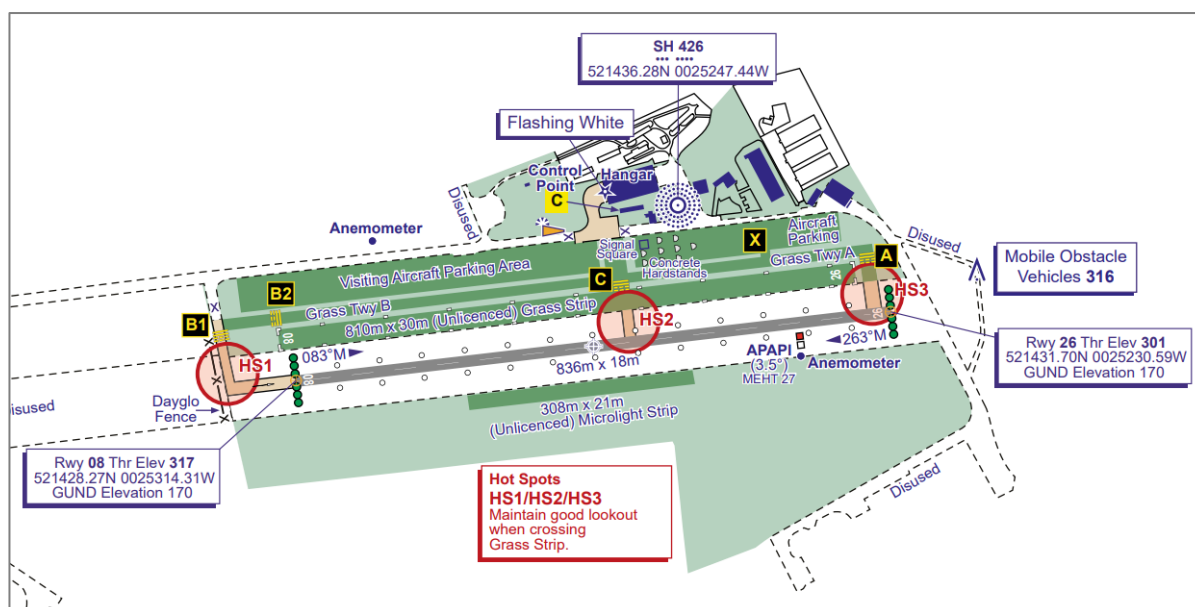
Figure 1 – Shobdon Airfield Diagram

The R22 [pilot] was conducting left-hand circuits VFR to the grass RW26 to the north of the main RW. The RV8 was inbound VFR from the south. [The pilots of] both aircraft were in receipt of an Aerodrome Flight Information Service. The Shobdon AFISO also had two aircraft ahead (a C152 and a PA28) joining to land, aircraft on the ground calling for taxi, and glider operations on the north-side of the main runway, which included calls from a vehicle associated with the gliding.
