AIRPROX REPORT No 2022028

Date: 07 Mar 2022 Time: 0821Z Position: 5137N 00041W Location: High Wycombe

PART A: SUMMARY OF INFORMATION REPORTED TO UKAB

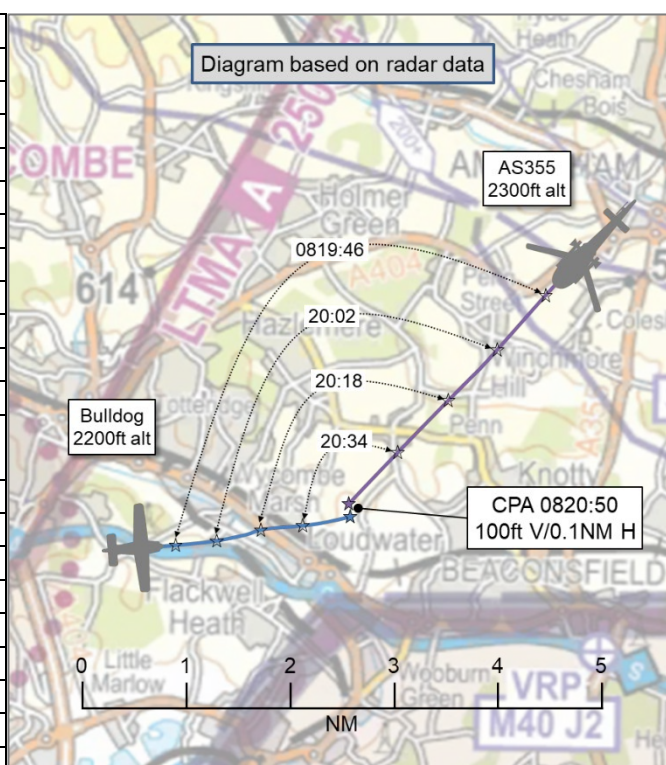
Recorded	Aircraft 1	Aircraft 2
Aircraft	Bulldog	AS355
Operator	Civ FW	Civ Helo
Airspace	London FIR	London FIR
Class	G	G
Rules	VFR	VFR
Service	Listening Out	Traffic
Provider	Farnborough LARS	Luton Radar
Altitude/FL	2200ft	2300ft
Transponder	A, C, S+	A, C, S+
Reported		
Colours	Red, white	Black
Lighting	Strobes, nav lights	Nav, anti-col, strobe
Conditions	VMC	VMC
Visibility	>10km	>10km
Altitude/FL	2200ft	1500-2000ft
Altimeter	QNH (1026hPa)	QNH (NK hPa)
Heading	080°	NK
Speed	110kt	120kt
ACAS/TAS	Not fitted	TAS
Alert	N/A	TA
Separation at CPA		
Reported	0ft V/100m H	NK V/NK H
Recorded	100ft V/0.1NM H
