AIRPROX REPORT No 2022025

Date: 08 Mar 2022 Time: 1052Z Position: 5217N 00016W Location: 4.5NM SW Huntingdon

PART A: SUMMARY OF INFORMATION REPORTED TO UKAB

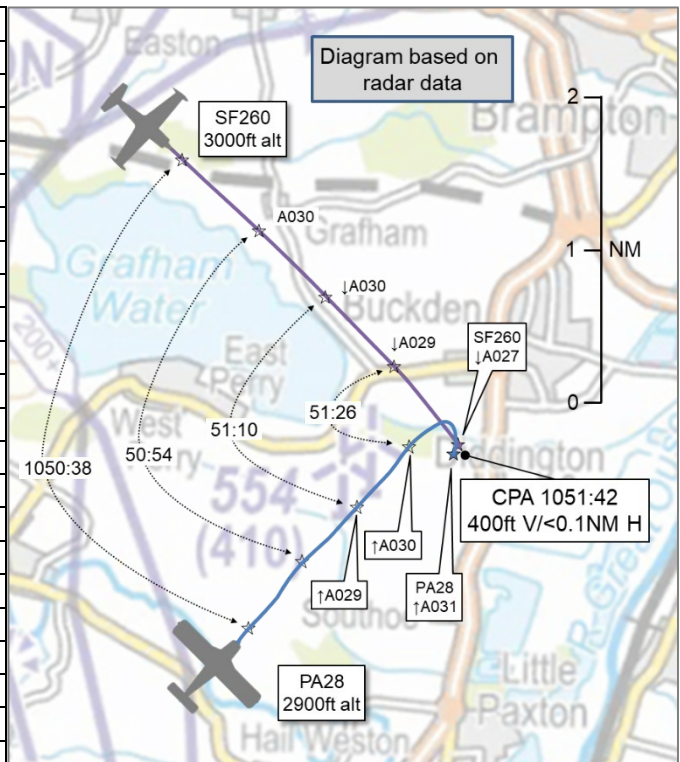
- The Duxford AFISO would not have been aware of the presence of the PA28 as its pilot was not on their frequency.
- ATSI noted that in this area, there is no published LARS available, see Figure 1.
