AIRPROX REPORT No 2022033

Date: 20 Mar 2022 Time: 1545Z Position: 5030N 00139W Location: IVO THRED

PART A: SUMMARY OF INFORMATION REPORTED TO UKAB

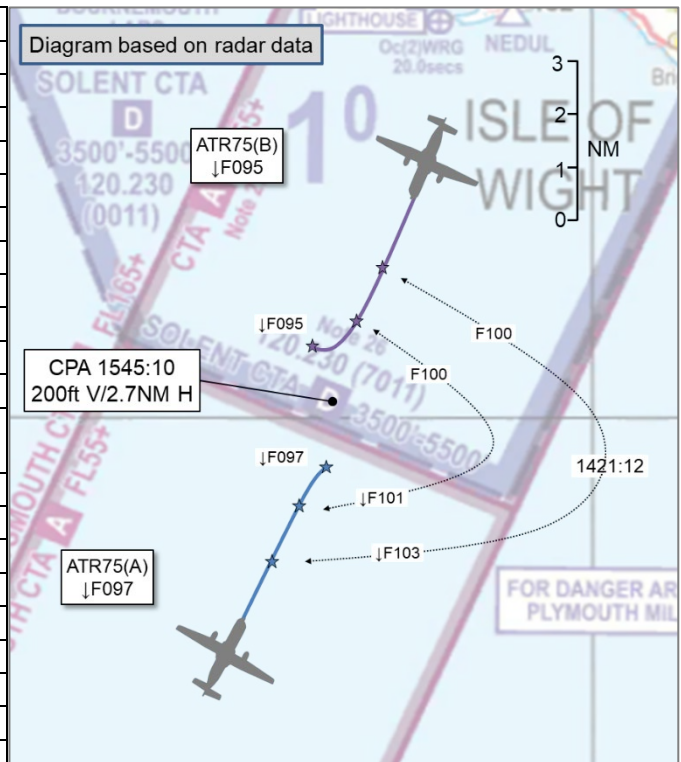
Recorded	Aircraft 1	Aircraft 2
Aircraft	ATR75(A)	ATR75(B)
Operator	CAT	CAT
Airspace	Airway N63	Airway N63
Class	A	A
Rules	IFR	IFR
Service	Radar Control	Radar Control
Provider	Solent	Swanwick
Altitude/FL	FL097	FL095
Transponder	A, C, S+	A, C, S+
Reported		
Colours	White, Blue	White, blue
Lighting	Nav	Nav, Anti-cols, Landing
Conditions	VMC	VMC
Visibility	>10km	>10km
Altitude/FL	FL105	FL100
Altimeter	1013hPa	1013hPa
Heading	025°	180°
Speed	240kt	240kt
ACAS/TAS	TCAS II	TCAS I
Alert	RA	TA
Separation at CPA		
Reported	NK	Not seen
Recorded	200ft V/2.7NM H
