AIRPROX REPORT No 2022042

Date: 28 Mar 2022 Time: 1502Z Position: 5351N 00109W Location: Leeds East ATZ

PART A: SUMMARY OF INFORMATION REPORTED TO UKAB

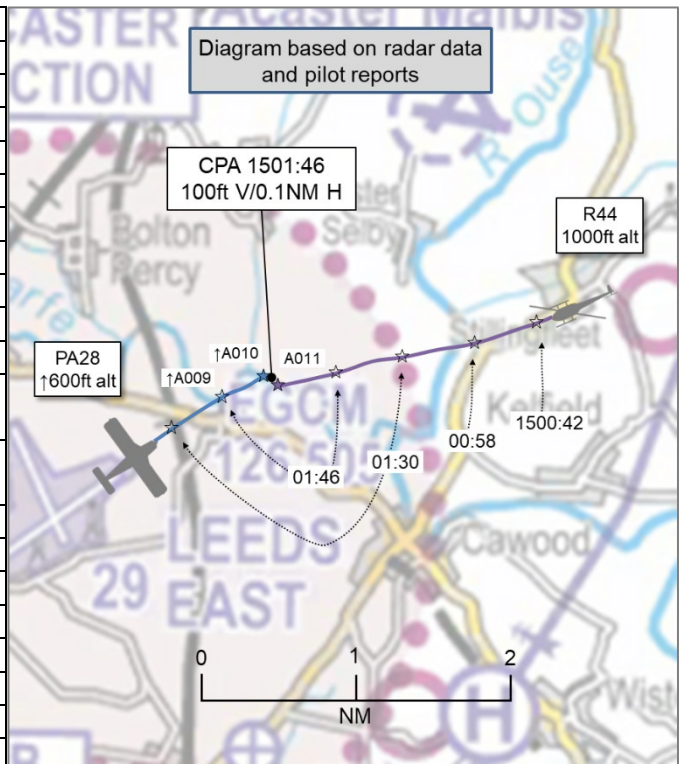
Recorded	Aircraft 1	Aircraft 2
Aircraft	PA28	R44
Operator	Civ FW	Civ Helo
Airspace	Leeds East ATZ	Leeds East ATZ
Class	G	G
Rules	VFR	VFR
Service	AGCS	AGCS
Provider	Fenton Radio	Fenton Radio
Altitude/FL	1000ft	1100ft
Transponder	A, C	A, C, S
Reported		
Colours	White, coloured tail	Red and gold
Lighting	Nav, Strobe, Landing	Nav, Strobe, HISL, Landing/Taxi
Conditions	VMC	VMC
Visibility	5-10km	<5km
Altitude/FL	800ft	1000ft
Altimeter	QFE (1021hPa)	QFE (NR hPa)
Heading	060°	240°
Speed	80kt	90kt
ACAS/TAS	Not fitted	Not fitted
Separation at CPA		
Reported	0ft V/100m H	100ft V/100m H
Recorded	100ft V/0.1NM H
