AIRPROX REPORT No 2022036

Date: 24 Mar 2022 Time: ~1922Z Position: 5149N 00121W Location: Oxford visual circuit

PART A: SUMMARY OF INFORMATION REPORTED TO UKAB

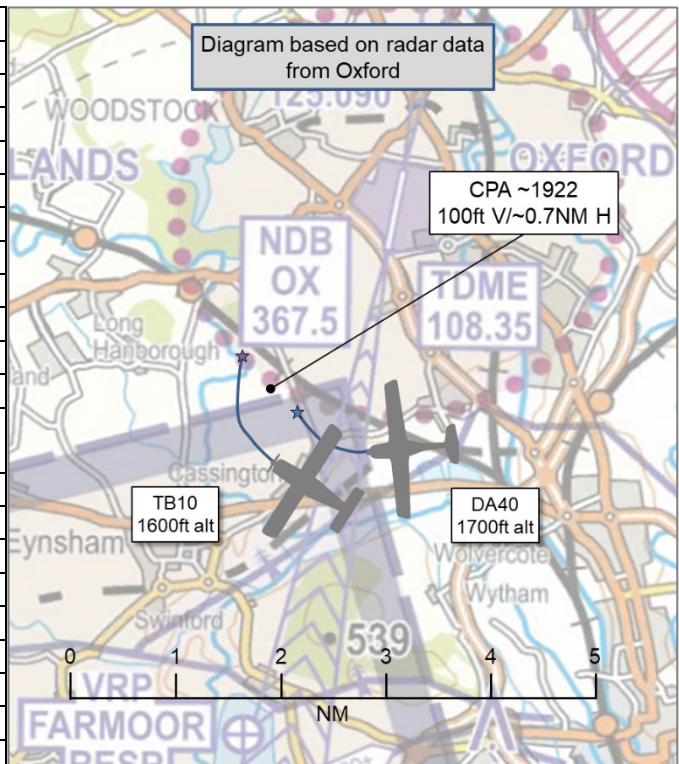
Recorded	Aircraft 1	Aircraft 2
Aircraft	DA40	TB10
Operator	Civ FW	Civ FW
Airspace	Brize CTR	Oxford ATZ
Class	D	G
Rules	VFR	VFR
Service	ACS	ACS
Provider	Oxford Tower	Oxford Tower
Altitude/FL	1700ft	1600ft
Transponder	A, C, S+	A, C
Reported		
Colours	White	NR
Lighting	Strobes, landing, nav	NR
Conditions	VMC (night)	NK
Visibility	>10km	NR
Altitude/FL	800ft	NR
Altimeter	QNH (1029hPa)	NK
Heading	170°	NR
Speed	NK	NR
ACAS/TAS	Not fitted	Unknown
Separation at CPA		
Reported	100ft V/0.25NM H	NR V/NR H
Recorded	100ft V/~0.7NM H
