AIRPROX REPORT No 2022050

Date: 14 Apr 2022 Time: 1328Z Position: 5247N 00044E Location: IVO West Raynham

PART A: SUMMARY OF INFORMATION REPORTED TO UKAB

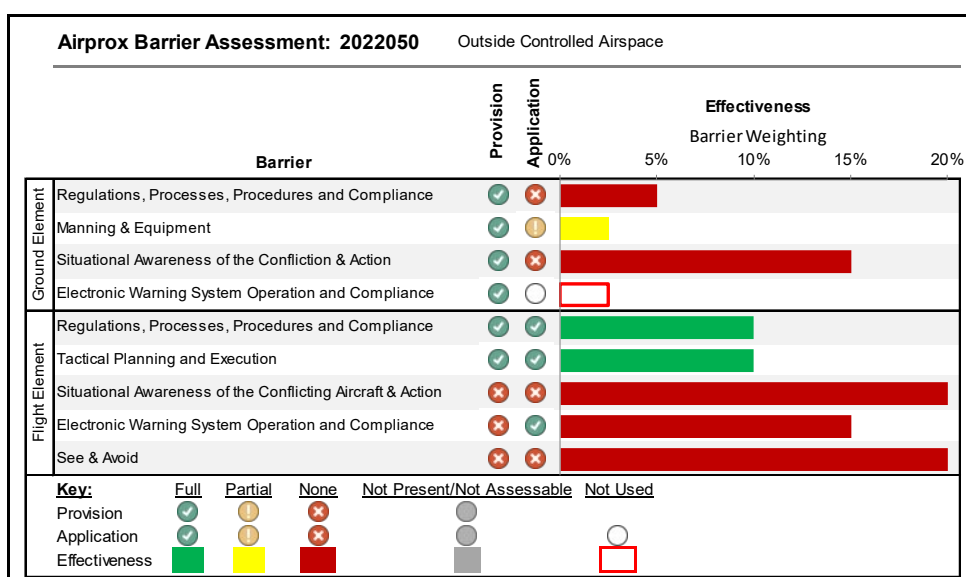
Electronic Warning System Operation and Compliance were assessed as **ineffective** because the EC on the C42 could not detect the F35s.

See and Avoid were assessed as **ineffective** because neither pilot saw the other aircraft in time to take any avoiding action.
