AIRPROX REPORT No 2022059

Date: 26 Apr 2022 Time: 1522Z Position: 5125N 00201W Location: 4NM N Lyneham

PART A: SUMMARY OF INFORMATION REPORTED TO UKAB

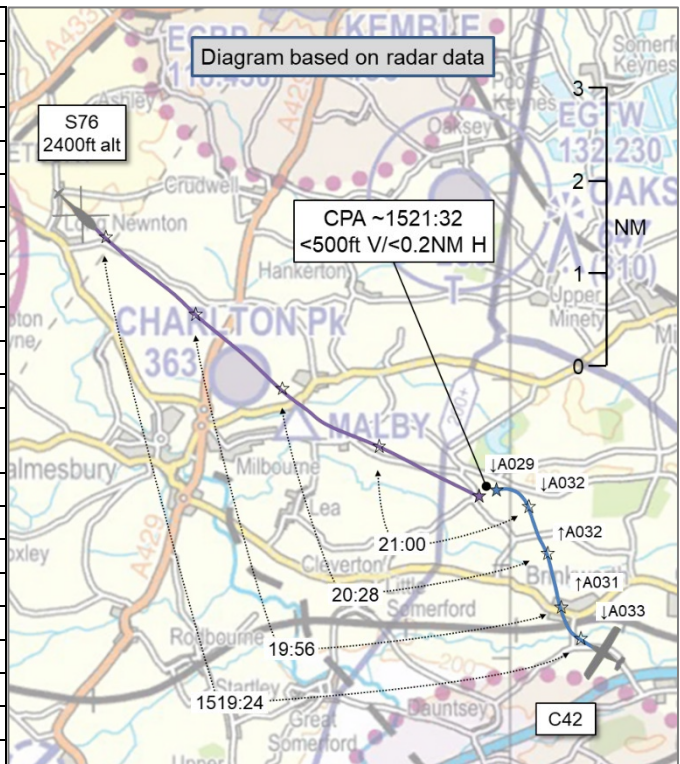
Recorded	Aircraft 1	Aircraft 2
Aircraft	C42	S76
Operator	Civ FW	Civ Comm
Airspace	London FIR	London FIR
Class	G	G
Rules	VFR	VFR
Service	Basic	Traffic
Provider	Kemble Info	Brize Radar
Altitude/FL	2900ft	2400ft
Transponder	A, C, S	A, C, S
Reported		
Colours	White	Maroon
Lighting	Nav, Strobe, Landing	Strobe, HISL, Nav, Landing
Conditions	VMC	VMC
Visibility	>10km	>10km
Altitude/FL	2500ft	2400
Altimeter	QNH (1022hPa)	QNH (NK hPa)
Heading	"SW"	120°
Speed	45kt	140Kt
ACAS/TAS	SkyEcho	TCAS I
Alert	None	Information
Separation at CPA		
Reported	150ft V/50m H	300ft V/0.5NM H
Recorded	<500ft V/<0.2NM H

An analysis of the NATS radar replay was undertaken and both aircraft were detected and identifiable. In the lead-up to the Airprox, the flightpaths of both aircraft could be seen to be consistent with the pilots' reports. However, the descent reported by the S76 pilot was not seen on the radar replay until the sweep after CPA. The radar head used has an 8sec sweep period and the CPA of 500ft vertically and 0.2NM horizontally was observed on two consecutive sweeps, therefore it is likely that actual CPA occurred between sweeps and is less than recorded and, as such, CPA is stated as less than that recorded.

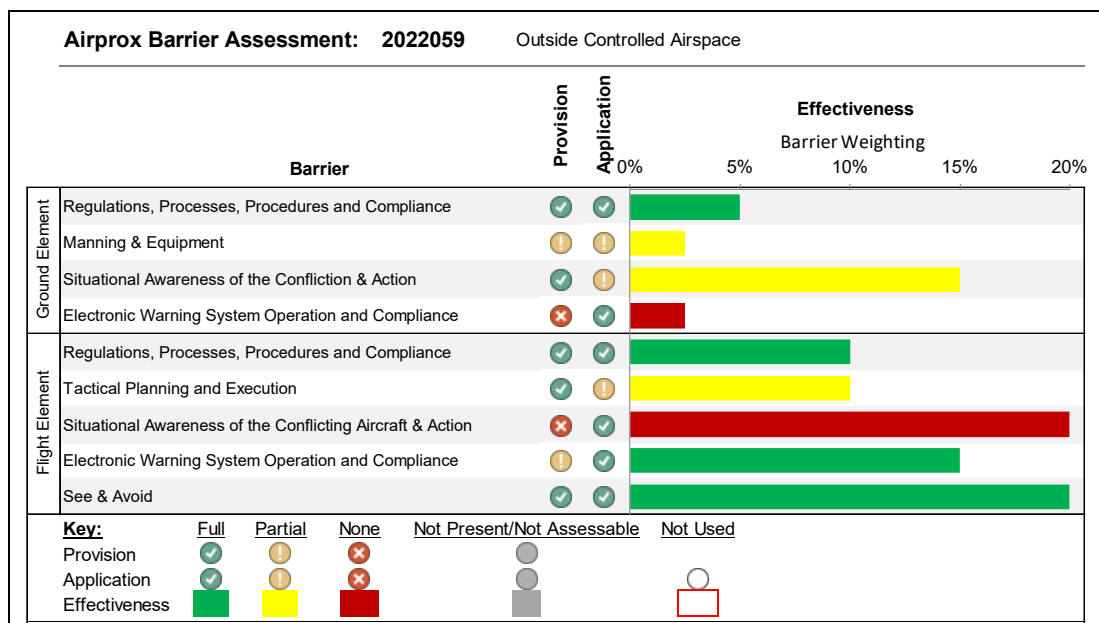
Electronic Warning System Operation and Compliance were assessed as **ineffective** because the system is not currently being utilised due to possible inconsistencies caused by legacy sensors.

Tactical Planning and Execution was assessed as **partially effective** because, during their HASELL check, the C42 pilot had not visually acquired the S76.

Situational Awareness of the Conflicting Aircraft and Action were assessed as **ineffective** because the C42 pilot had had no prior awareness of the presence of the S76.
