AIRPROX REPORT No 2022073

Date: 06 May 2022 Time: 1005Z Position: 5216N 00117W Location: 4NM W Daventry

PART A: SUMMARY OF INFORMATION REPORTED TO UKAB

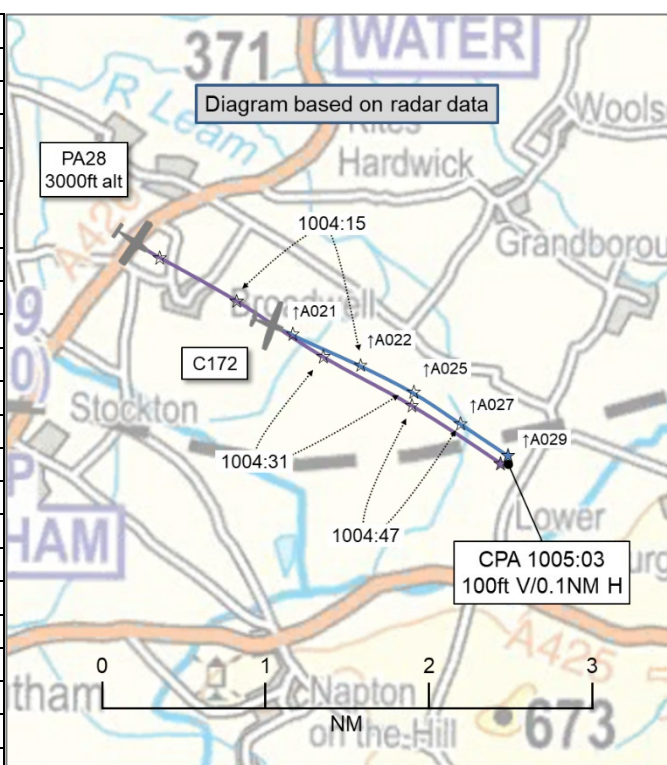
Recorded	Aircraft 1	Aircraft 2
Aircraft	C172	PA28
Operator	Civ FW	Civ FW
Airspace	London FIR	London FIR
Class	G	G
Rules	VFR	VFR
Service	Basic	Traffic
Provider	Coventry Info	Birmingham Radar
Altitude/FL	2900ft	3000ft
Transponder	A, C, S	A, C, S+
Reported		
Colours	Blue, White	White, Blue
Lighting	"IFR fit"	Strobe, Nav
Conditions	VMC	VMC
Visibility	>10km	>10km
Altitude/FL	3000ft	3000ft
Altimeter	QNH (1025hPa)	QNH (NK hPa)
Heading	120°	130°
Speed	100kt	130kt
ACAS/TAS	Not fitted	SkyEcho
Alert	N/A	None
Separation at CPA		
Reported	0ft V/10m H	20ft V/100m H
Recorded	100ft V/0.1NM H
