AIRPROX REPORT No 2022088

Date: 28 May 2022 Time: 1148Z Position: 5354N 00257W Location: Stalmine

PART A: SUMMARY OF INFORMATION REPORTED TO UKAB

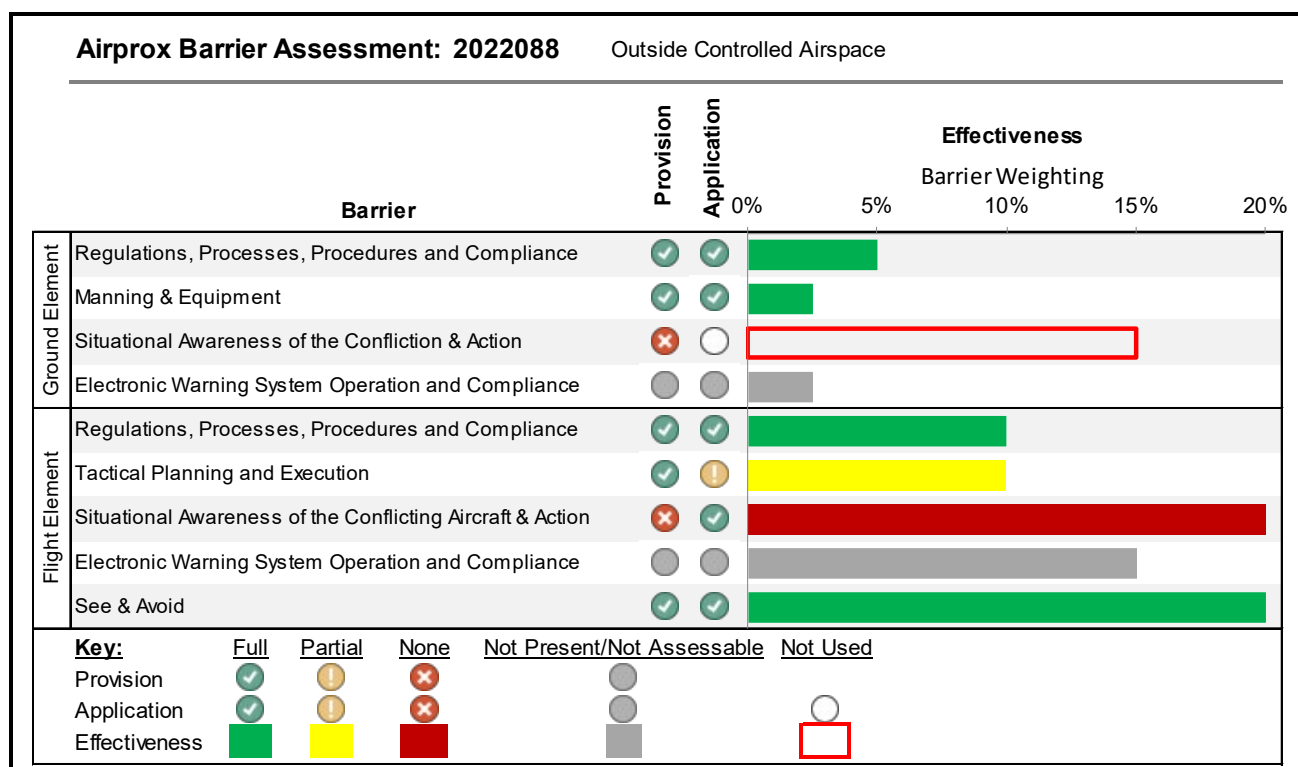
Situational Awareness of the Confliction and Action were assessed as **not used** because the Skyranger pilot was not in receipt of a FIS and the PA28 pilot was in receipt of a Basic Service, where the controller is not required to monitor the aircraft's track and in this case could not due to lack of surveillance capability.

Tactical Planning and Execution was assessed as **partially effective** because the PA28 pilot's turn took them into proximity with the Skyranger.

Situational Awareness of the Conflicting Aircraft and Action were assessed as **ineffective** because neither pilot was aware of the presence of the other aircraft until sighted.
