AIRPROX REPORT No 2022089

Date: 22 May 2022 Time: 0918Z Position: 5117N 00101W Location: Old Basing

PART A: SUMMARY OF INFORMATION REPORTED TO UKAB

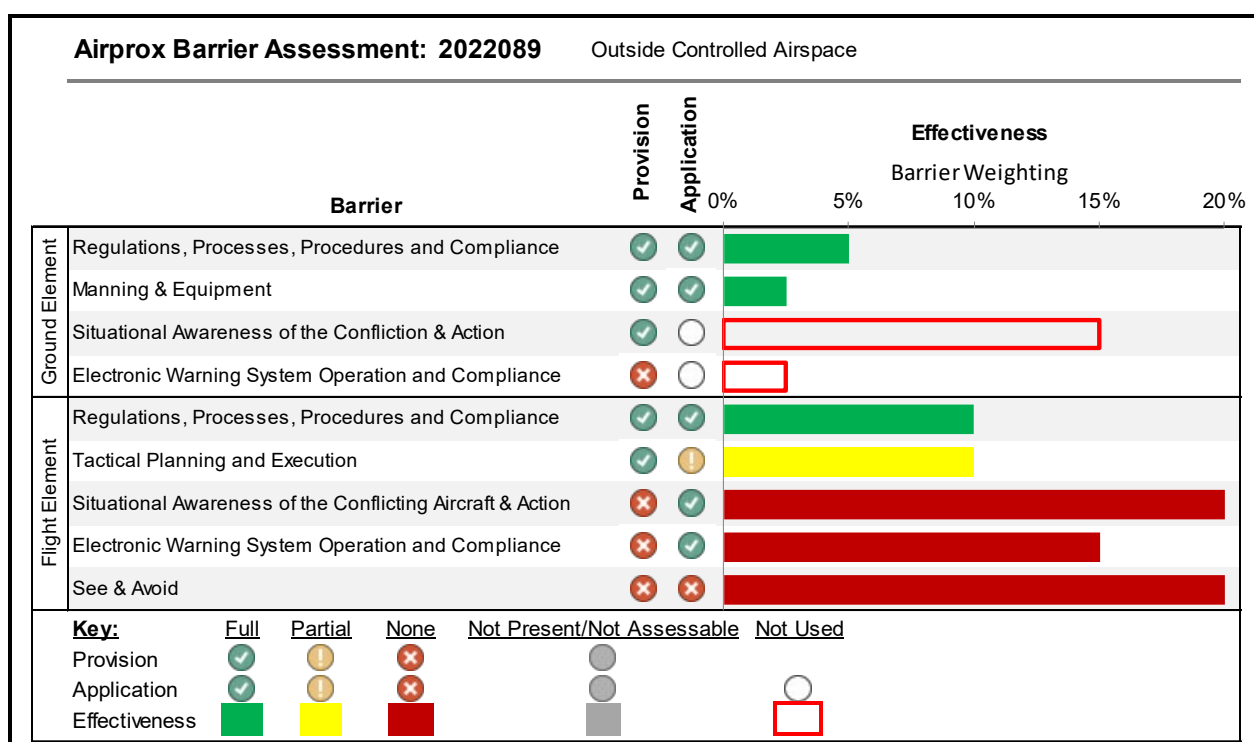
Electronic Warning System Operation and Compliance were assessed as **ineffective** because the PA28 was not equipped with any form of additional EC equipment and the EC equipment carried on the TB10 could not alert or warn on the PA28.

See and Avoid were assessed as **ineffective** because the PA28 pilot did not see the TB10 and the TB10 pilot saw the PA28 at about CPA, effectively a non-sighting.
