AIRPROX REPORT No 2022101

Date: 10 Jun 2022 Time: 1552Z Position: 5148N 00055W Location: 3NM SSE Westcott

PART A: SUMMARY OF INFORMATION REPORTED TO UKAB

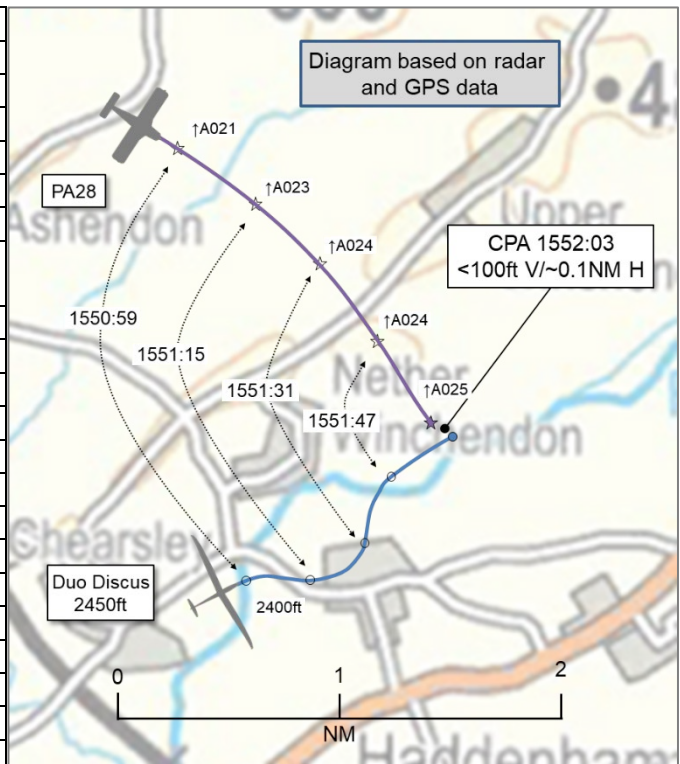
| Recorded | Aircraft 1 | Aircraft 2 |
|---|---|---|
| Recorded | <100ft V/~0.1NM H | |

An analysis of the NATS radar replay was undertaken and the PA28 was detected and identified using Mode S information. A primary-only contact was observed in the vicinity of the PA28 which may have been the Duo Discus but this could not be verified. However, the Duo Discus pilot was able to supply the UKAB Secretariat with a GPS data file detailing their flight. The radar and GPS data have been combined to construct the diagram and determine the CPA which has been recorded as an approximation due to the use of differing information sources.
