AIRPROX REPORT No 2022100

Date: 09 Jun 2022 Time: 1515Z Position: 5242N 00040E Location: 5NM NE RAF Marham

PART A: SUMMARY OF INFORMATION REPORTED TO UKAB

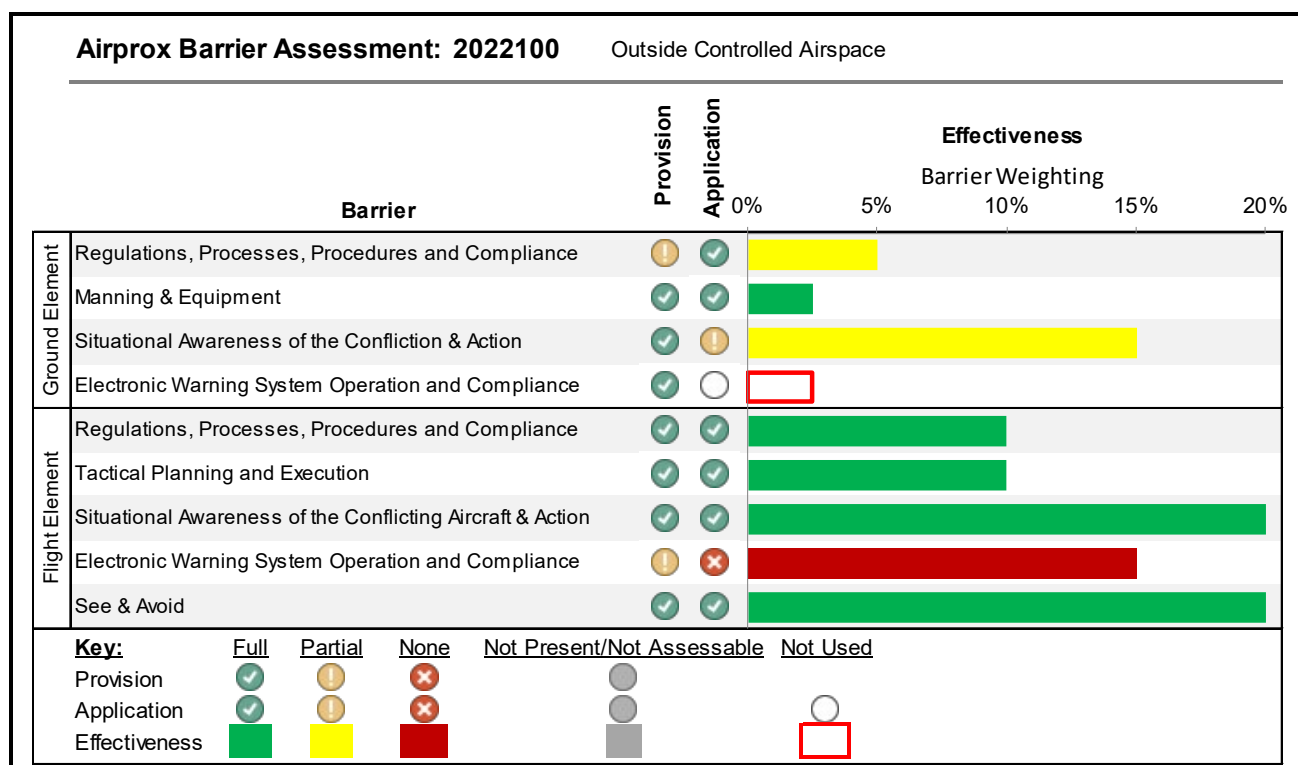
Flight Elements:

Electronic Warning System Operation and Compliance were assessed as **ineffective** because there was no alert from the C182 TAS when one could have been expected.
