AIRPROX REPORT No 2022108

Date: 20 Jun 2022 Time: 1031Z Position: 5207N 00003E Location: Barrington

PART A: SUMMARY OF INFORMATION REPORTED TO UKAB

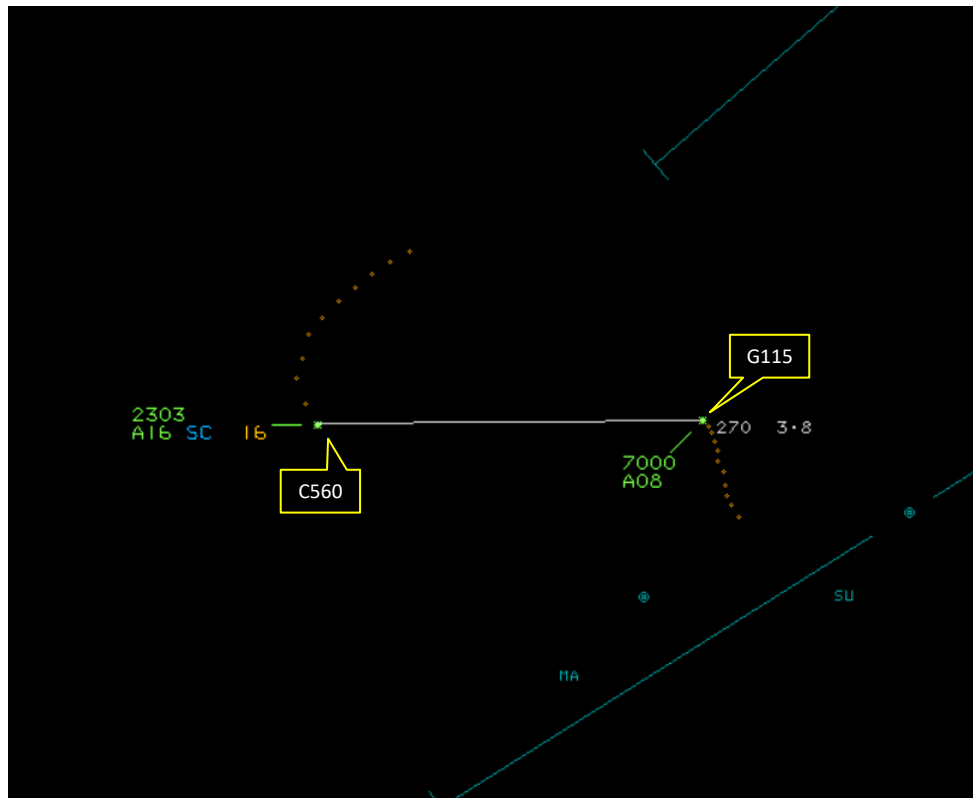
Figure 7 – 1030:00

At 1030:10 the Cambridge controller advised the pilot of the C560: *“Just caution sir I am non-radar. I can see a return on the ATM believed to be southwest of Cambridge, believed to be north-westbound indicating 1000ft. Just advise if you wish to discontinue the approach, keep a very good lookout”* (Figure 8).

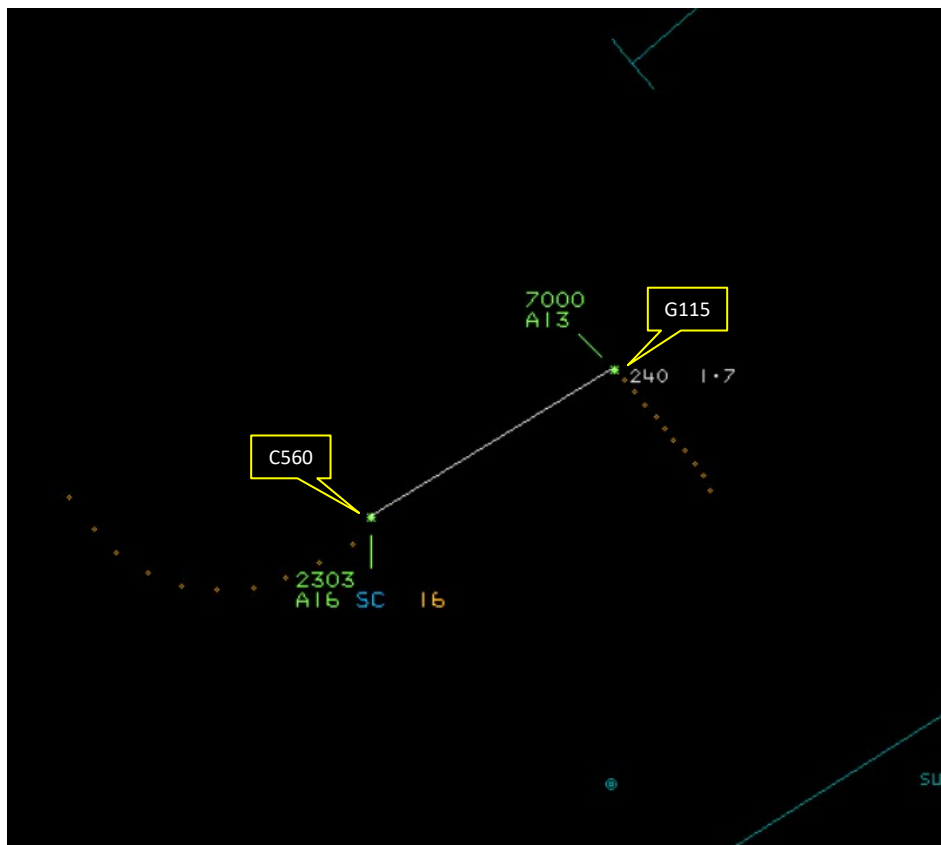
Figure 9 – 1030:40

The pilot replied *“Roger wilco. Where’s the traffic is it right-left or left-right?”* The controller replied *“I’m non-radar so I can’t tell. But I believe he’s north-westbound passing 1000ft in the climb”*, which the pilot acknowledged *“yeah, no worries”*.
